SH58 & SH59 Porirua Region

Existing Road - Safe System Audit Report

Prepared for Waka Kotahi

REVISION 1 - MARCH 2023

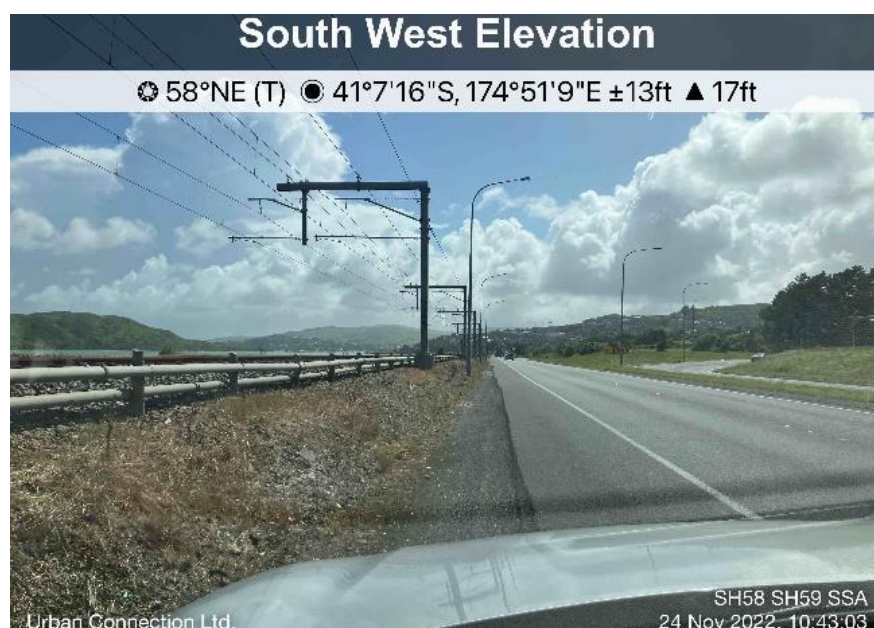
- 059-0020/2.800 RHS: Non-frangible poles and train/railway (narrow offset from the road);
- 059-0020/3.650 RHS: Non-frangible concrete end (The Ramp interchange);
- 059-0020/4.430 RHS: Non-frangible concrete end (Mungavin Avenue interchange);
- 059-0020/3.960 to 4.700: Metal fence over the concrete median barrier. This represents a snagging hazard for motorcyclist handlebars;

The probability of crashes against these hazards has been assessed as 'Unlikely' due to the predominantly straight and flat alignment and moderate to wide sealed shoulders. However, impact speeds of over 90 km/h with these unprotected hazards could result in 'Fatal' crashes.

Against non-frangible objects
Probability	Unlikely	Straight alignment and wide shoulders
Severity	Fatal	Impact speeds > 90 km/h

Figure 5.3-1 – Poles and railway hazard

1. *Identify roadside hazards and either remove, relocate, underground, or protect with roadside barriers;*
2. *Consider opportunities for additional roadside barrier protection by extending the length of existing barriers (during replacement) to close off roadside hazards further.*

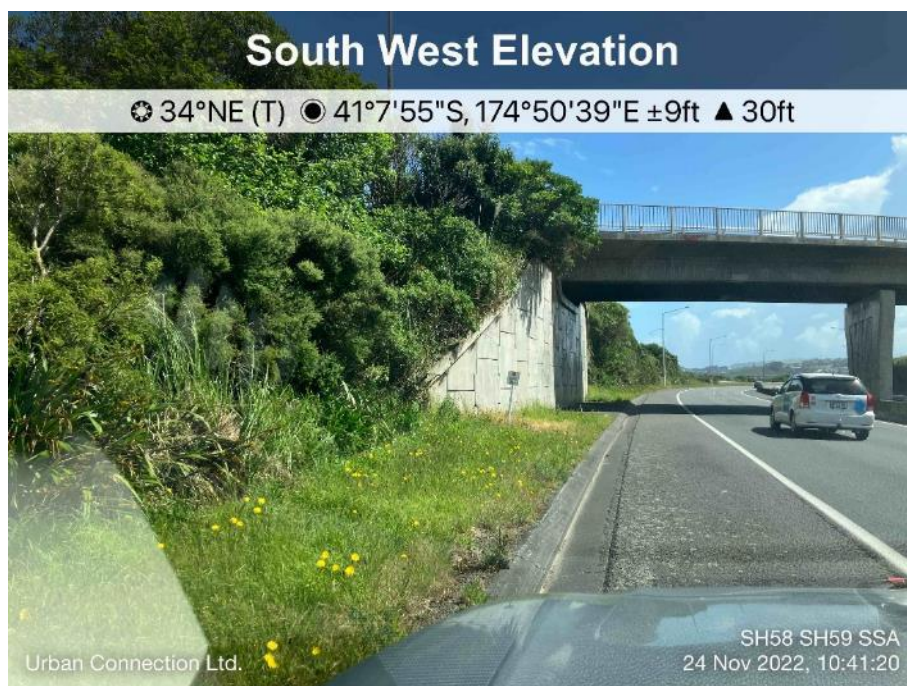
Figure 5.3-2 – Non-frangible concrete end (The Ramp interchange)

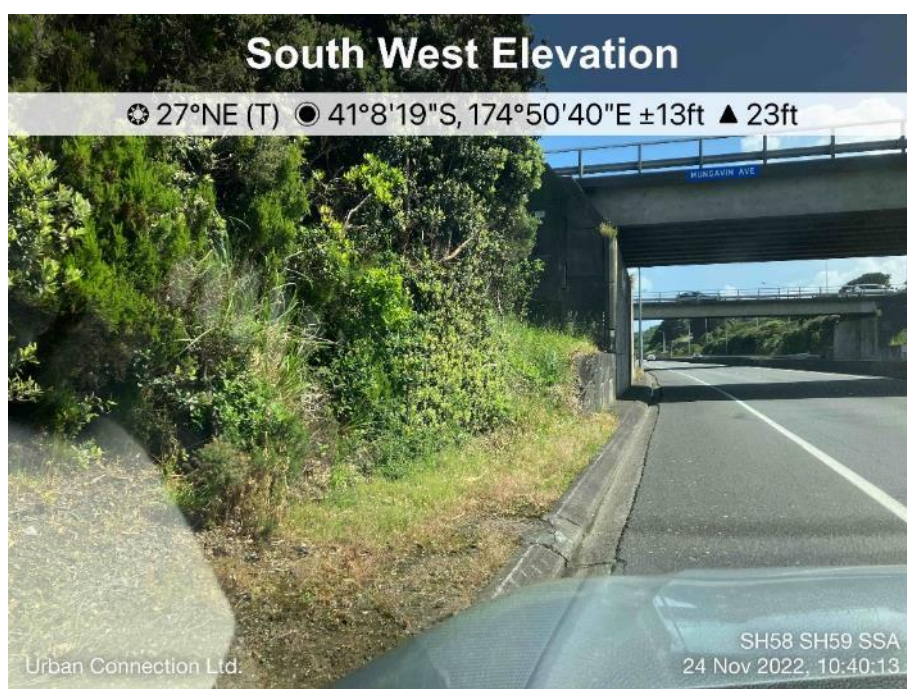
Figure 5.3-3 – Non-frangible concrete end (Mungavin Avenue interchange)

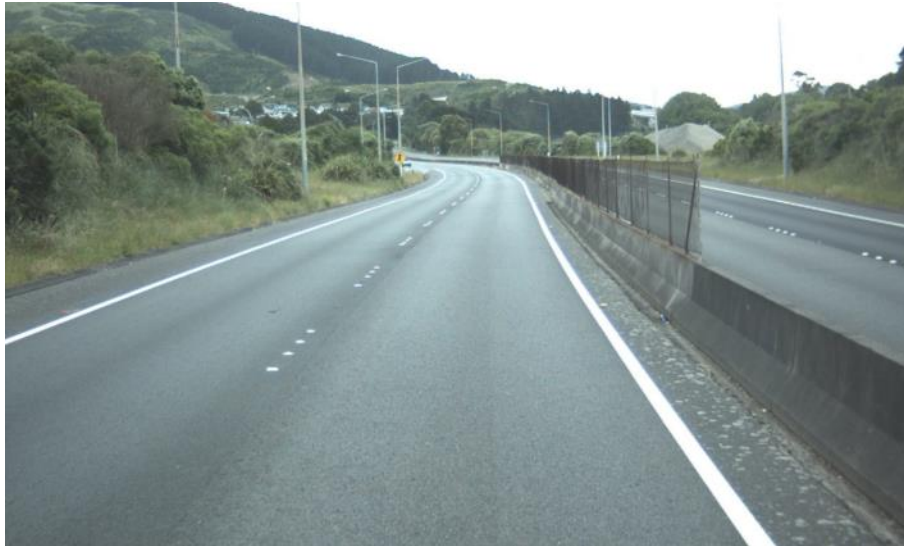
Figure 5.3-4 – Steel fence (Mungavin Avenue interchange)

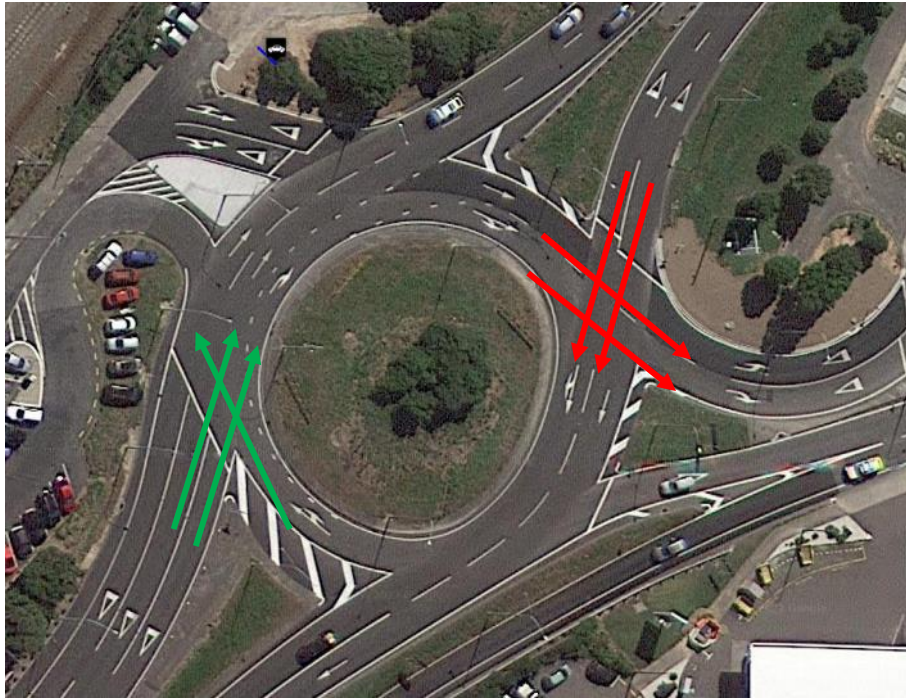
During the site visit, the SSA team observed a near-miss crash at the SH59/SH58 roundabout. This near-miss crash involved a southbound vehicle on SH59 and a vehicle turning right onto SH58. The near-miss crash seemed to be a result of excessive approach speed for the southbound vehicle, which has been noted on other vehicles approaching the roundabout. Note that the posted speed limit in this area is 50 km/h, but some vehicles appear to exceed the speed limit.

The observed safety hazard could be a result of an insufficient entry deflection on the north side of the roundabout. For instance, it can be observed that the conflict angle between approaching southbound vehicles and others on the circulating carriageway is somewhat close to 90 degrees, likely to generate high impact angles (refer to red arrows in Figure 5.3-5). This is unusual for a typical roundabout layout. In turn, high impact angles are likely to result in more severe crashes. In contrast, the southern approach generates lower impact angles, likely to result in less severe crashes (refer to green arrows below).

Side-impact at high impact angles
Probability	Likely	Relatively high impact speeds and high traffic volumes
Severity	Serious	Impact speeds of 50-60 km/h

Figure 5.3-5 – Intersection layout and conflict angles at the SH59/SH58 roundabout

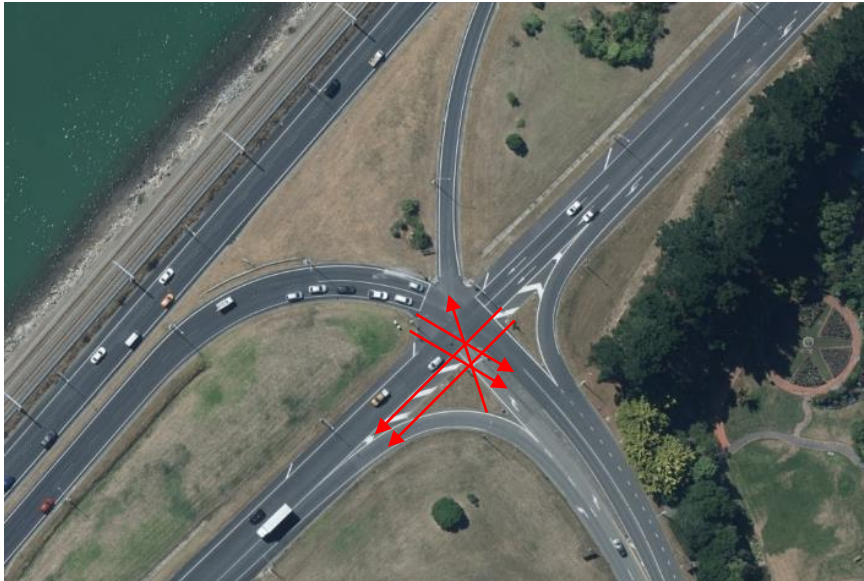
Rear-end collisions
Probability	Likely	Traffic signals in a high-speed area with high traffic volumes
Severity	Serious	Impact speeds > 90 km/h

Figure 5.3-6 – Intersection layout and conflict angles at the Whitford Brown intersection

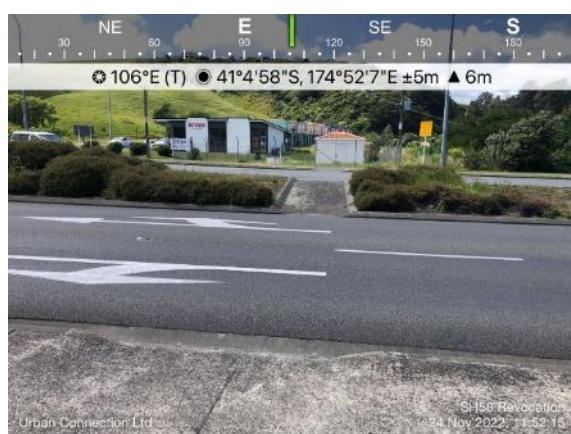
Against vulnerable road users (pedestrians)
Probability	Likely	Long crossing distance, long distance between facilities, no mid-block facilities, short signal pedestrian phase, no TGSi
Severity	Fatal	Impact speeds ≥ 50 km/h

Figure 5.4-1 – Crossing/kerb cutdown at the Plimmerton Roundabout

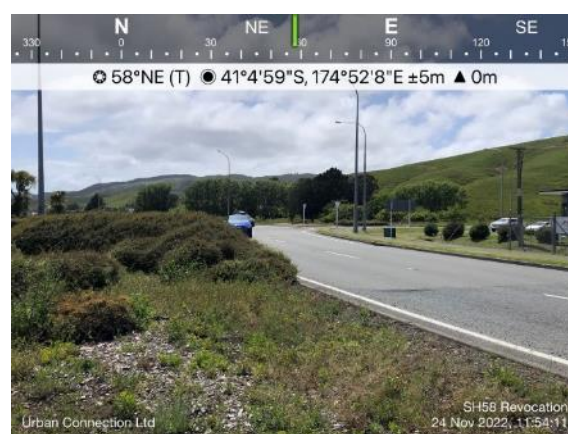
Figure 5.4-2 – Visibility at the Plimmerton Roundabout

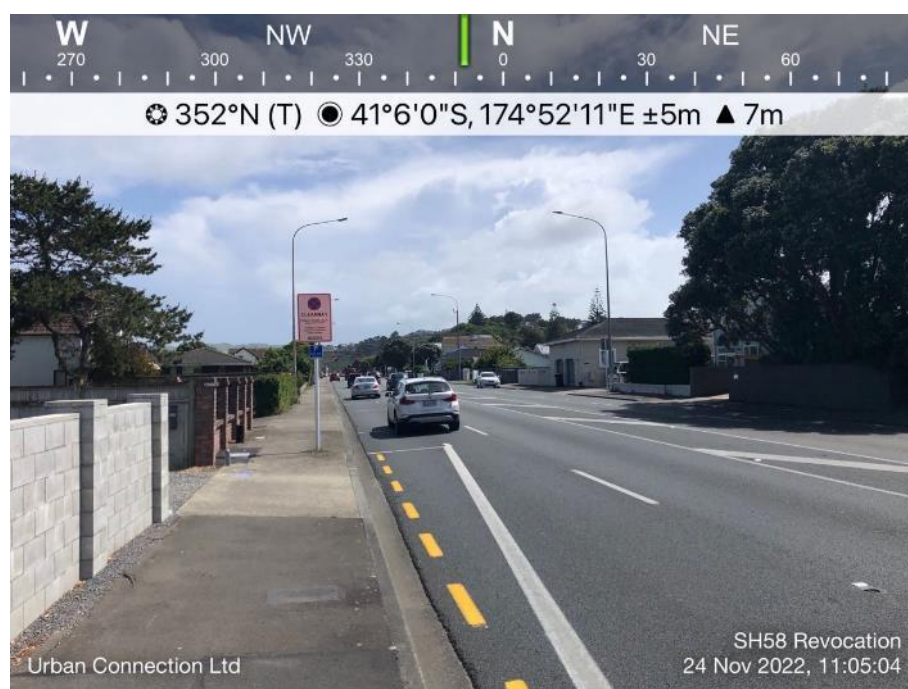
Against vulnerable road users (cyclists)
Probability	Likely	No cycling facilities, no treatment at intersections, informal shared use, parked vehicles, poor connectivity to the off-road pathway, no cycle crossing /refuge
Severity	Fatal	Impact speeds ≥ 50 km/h

Figure 5.4-3 – Road cross-section (no cycling facilities)

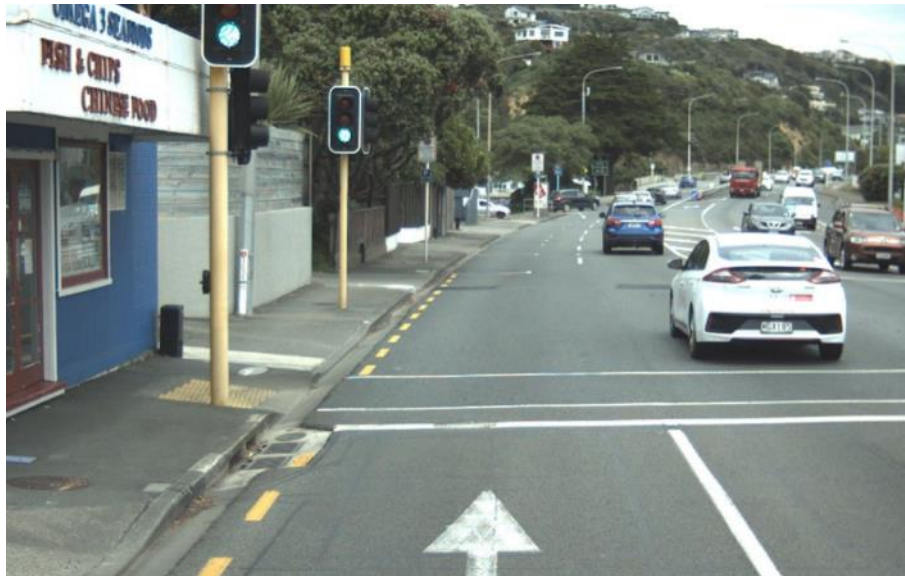
Against vulnerable road users (pedestrians and cyclists)
Probability	Unlikely	Obstacles reduce path width, but a relatively low number of users and walking/riding speeds
Severity	Minor	Impact speeds of < 20 km/h

Figure 5.4-4 – Footpath width adversely affected by signal poles

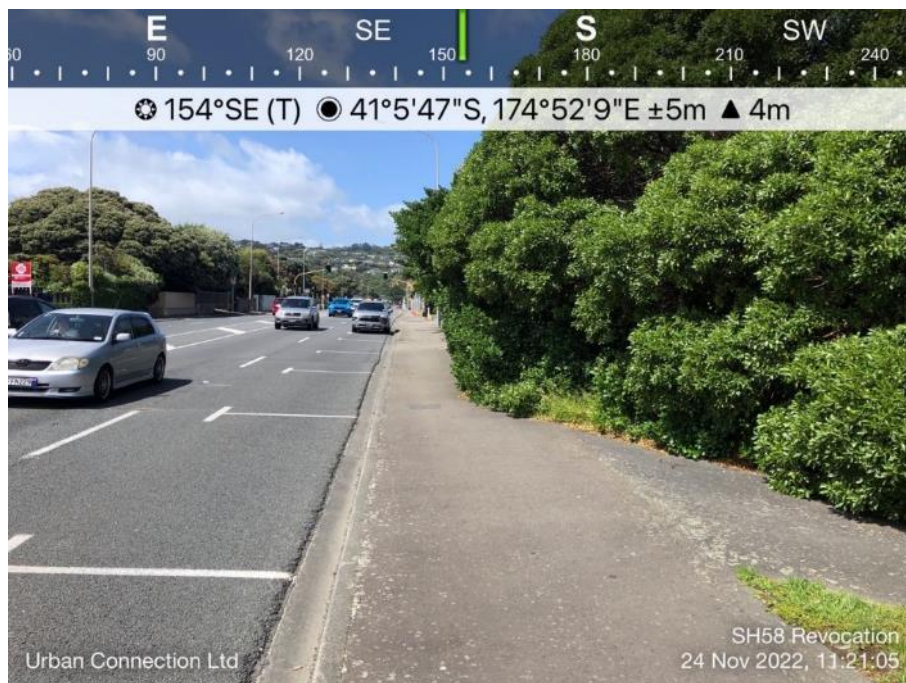
Figure 5.4-5 – Section of the path with overgrown vegetation

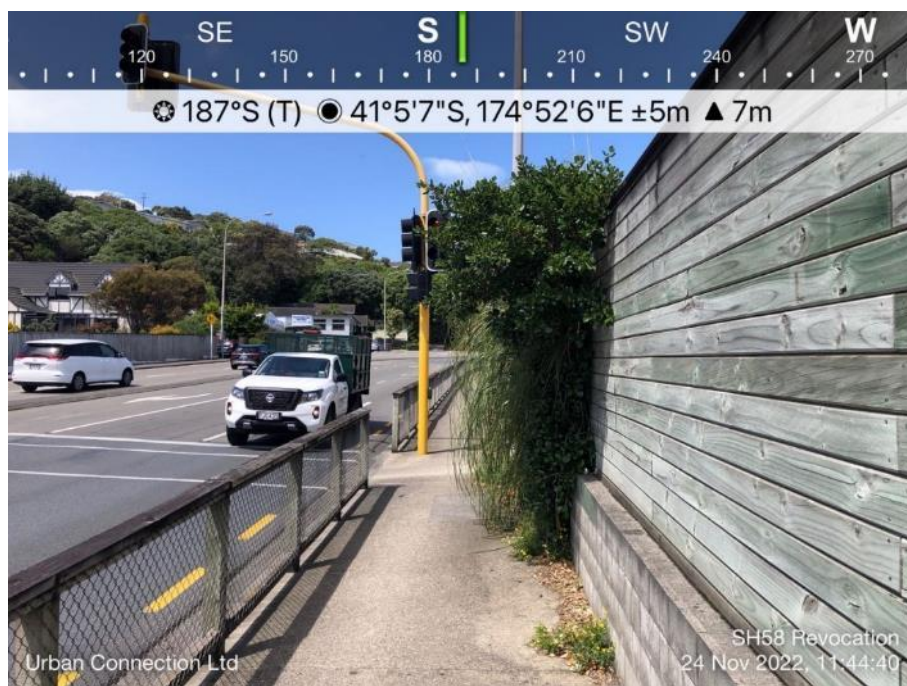
Figure 5.4-6 – Overgrown vegetation

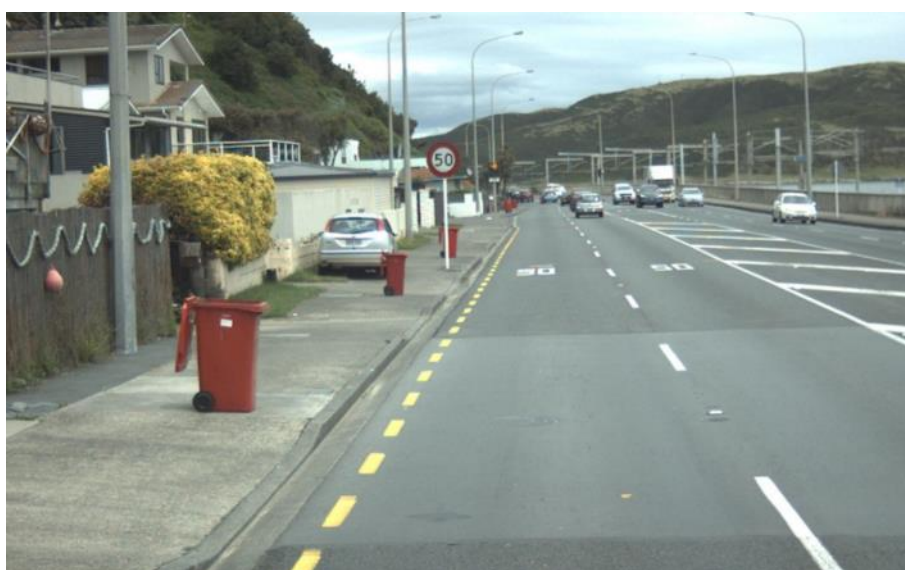
Figure 5.4-7 – Rubbish bins and car parked on the footpath

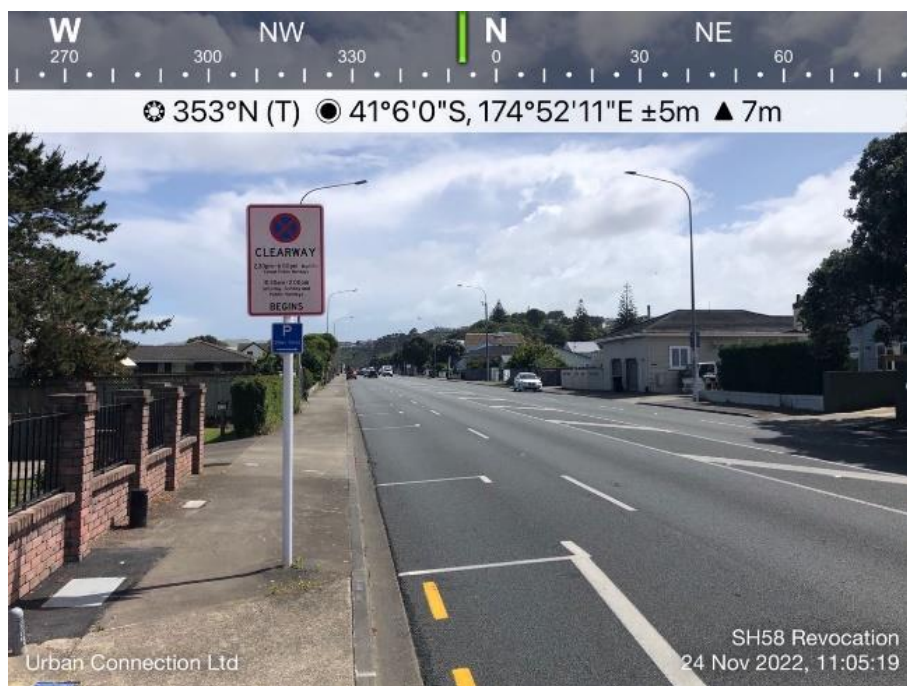
Side-impact at high impact angles
Probability	Unlikely	Restricted visibility due to parked vehicles
Severity	Serious	Impact speeds \geq 50 km/h

Figure 5.4-8 – On-street parking spaces

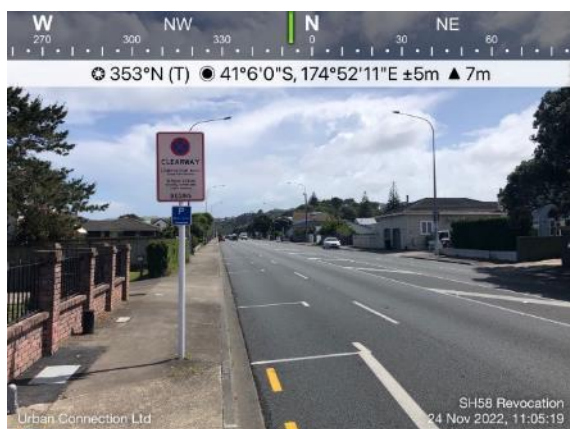
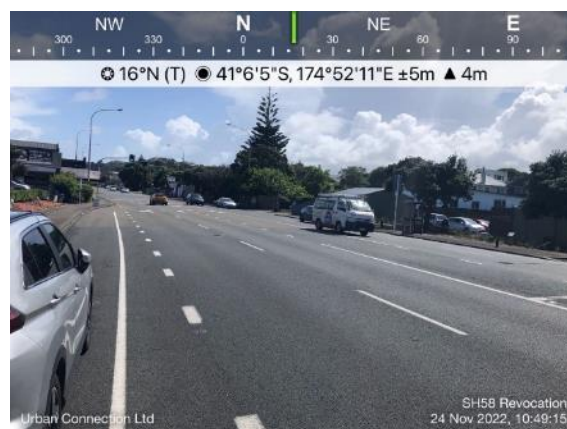
Side-impact at high impact angles
Probability	Likely	Difficult decision-making, high traffic volumes and driveway frequency
Severity	Serious	Impact speeds ≥ 50 km/h

Figure 5.4-9 – Road cross-section on Mana Esplanade

Figure 5.4-10 – Road cross-section on Mana Esplanade

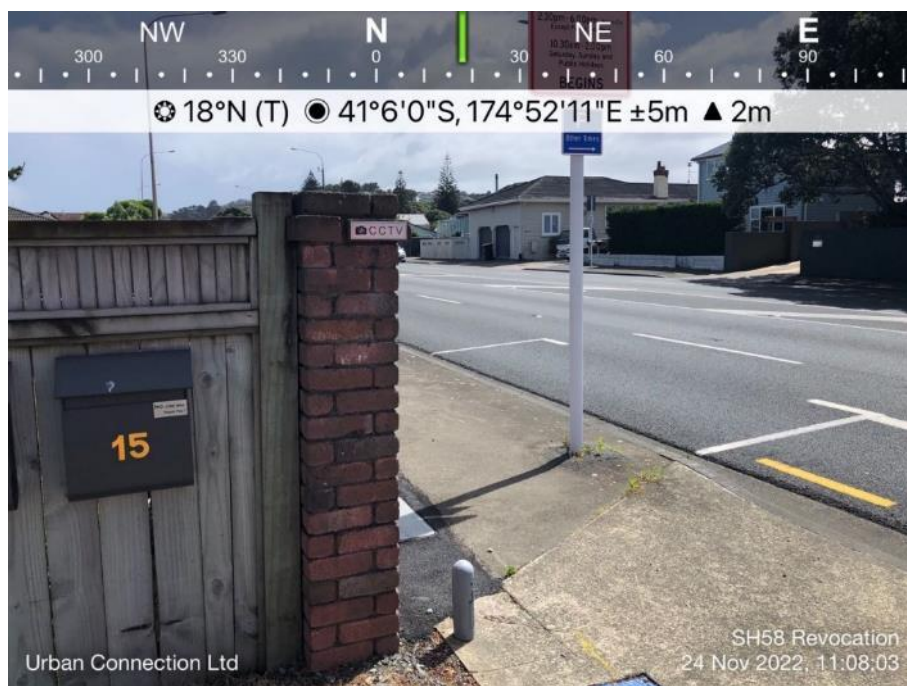
Against vulnerable road users (pedestrians)
Probability	Unlikely	Slow speeds of vehicles exiting driveways
Severity	Minor	Impact speeds ≤ 20 km/h

Figure 5.4-11 – Visibility from a driveway

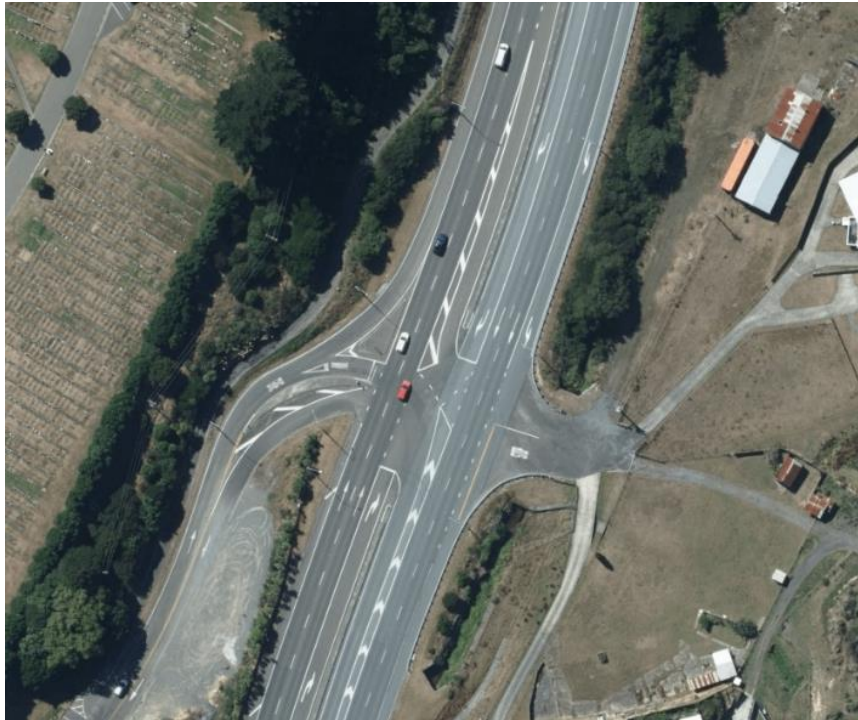
Side-impact at high impact angles
Probability	Very Unlikely	Risk is decreased by reaction and braking distance available and low traffic volumes on the side road
Severity	Fatal	Impact speeds > 90 km/h

Figure 5.5-1 – Intersection layout

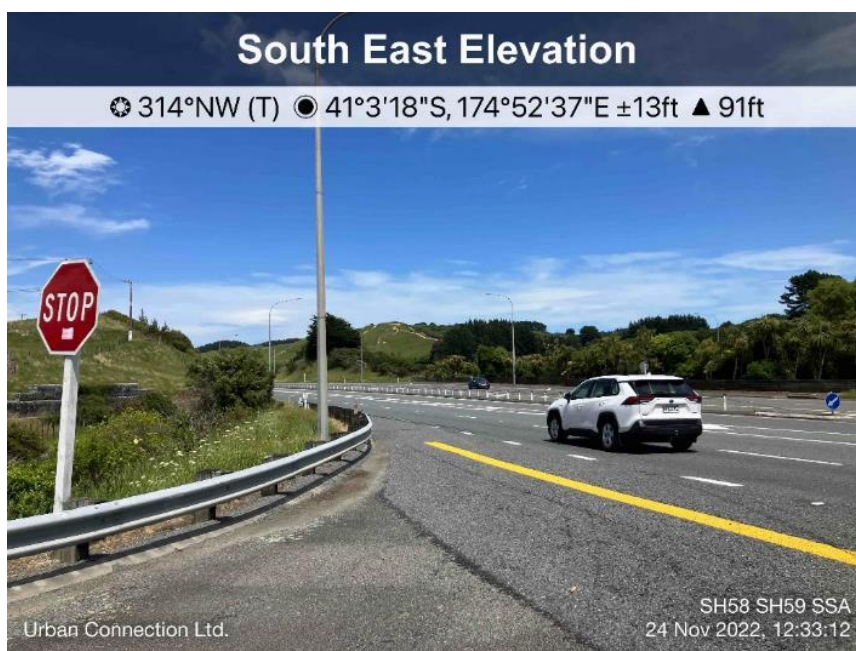
Figure 5.5-2 – Visibility from Arlie Road (East)

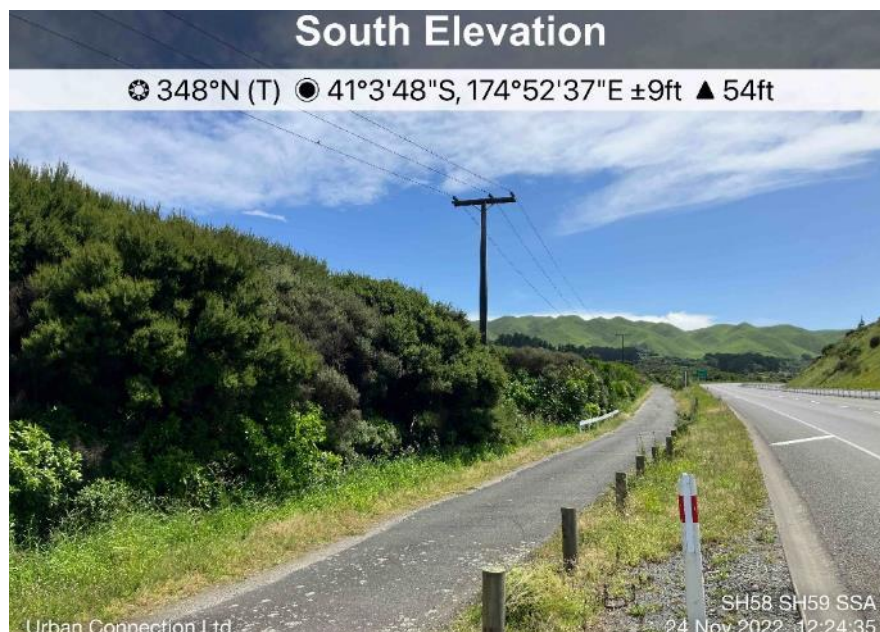
Against non-frangible objects and/or vulnerable road users
Probability	Unlikely	Straight to moderately curved and wide shoulders
Severity	Fatal	Impact speeds > 90 km/h

Figure 5.5-3 – Non-frangible wooden bollards

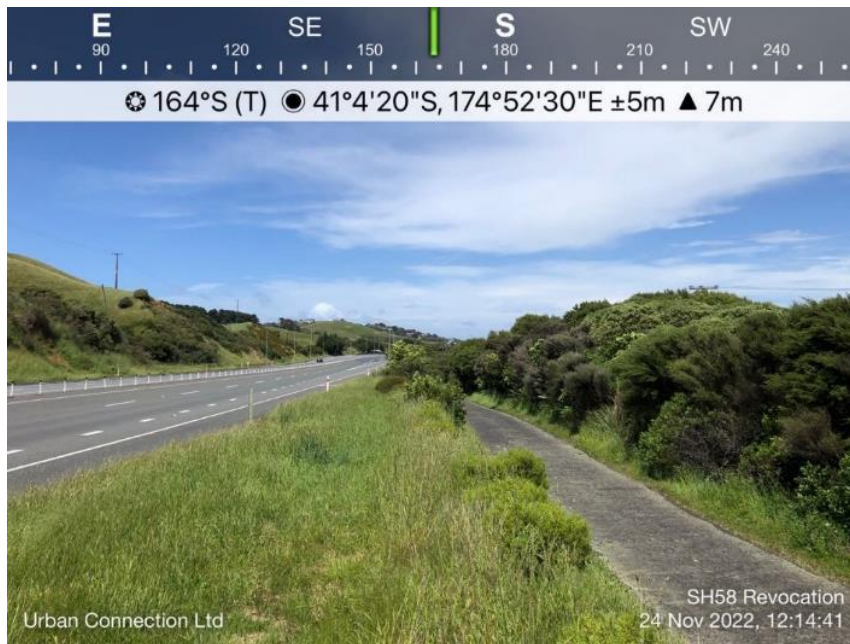
Figure 5.5-4 – Unprotected drop-off and trees hazard

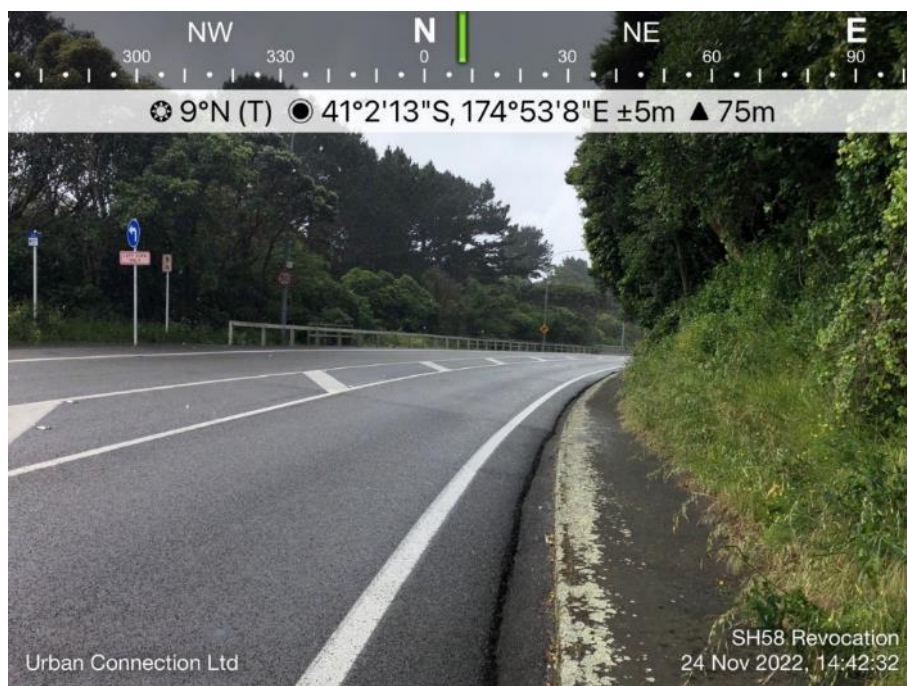
Against vulnerable road users (pedestrians)
Probability	Likely	Poor intervisibility, windy alignment, scarce crossing opportunities, no crossing treatment, no TSGI
Severity	Fatal	Impact speeds of 40-50 km/h

Figure 5.6-1 – Visibility to the north from the existing pedestrian refuge

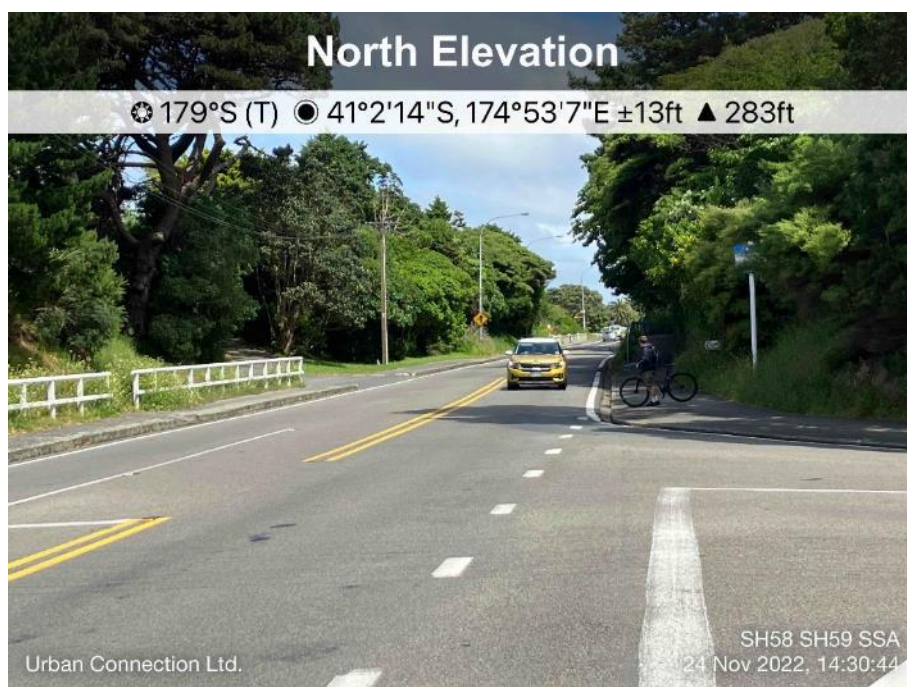
Figure 5.6-2 – Cyclist waiting to cross the road (no crossing treatment)

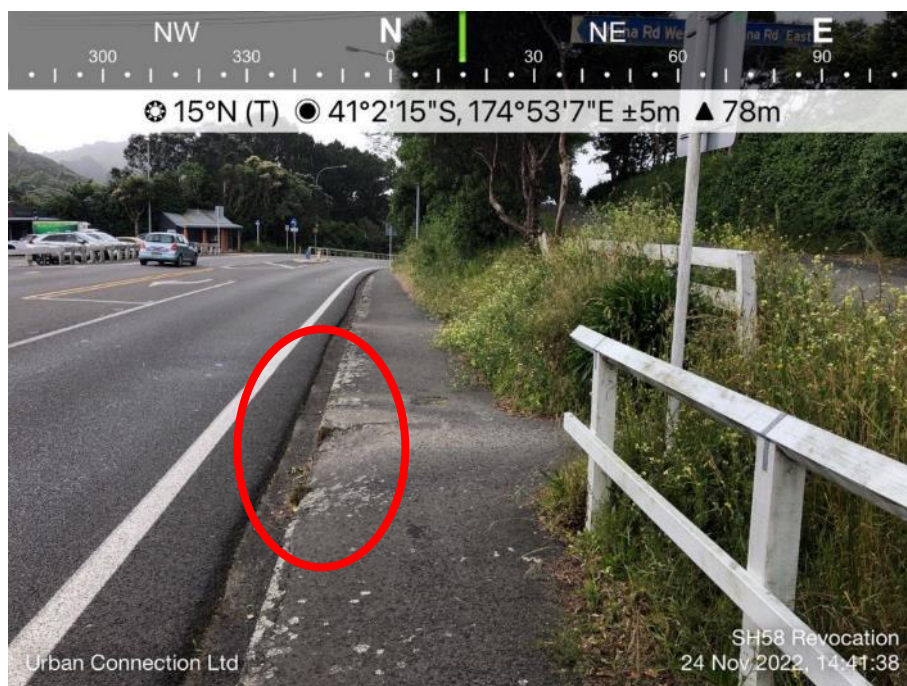
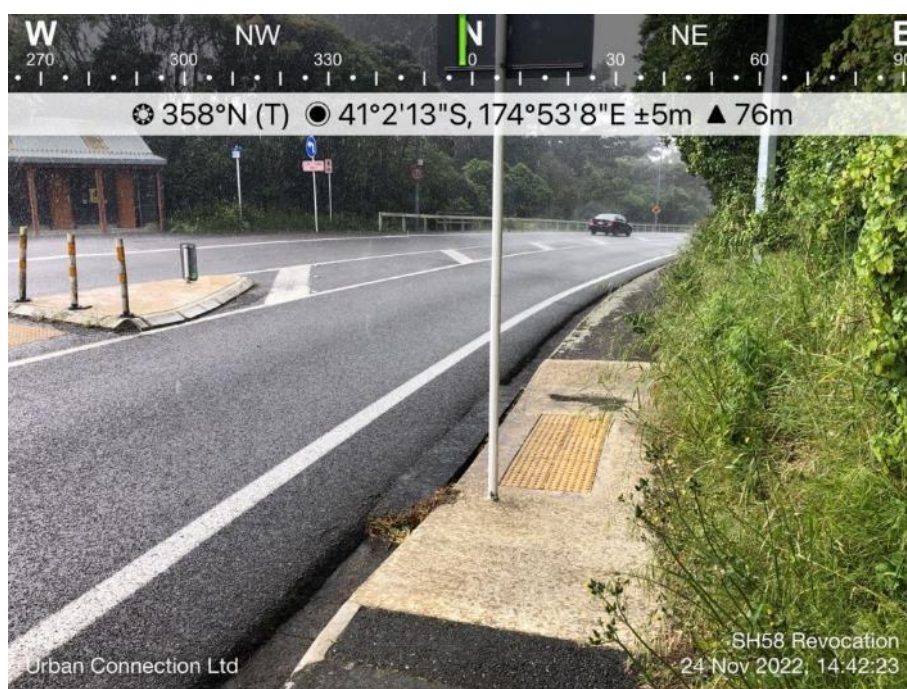
Figure 5.6-3 – Existing kerb crossing

Figure 5.6-4 – Existing kerb crossing

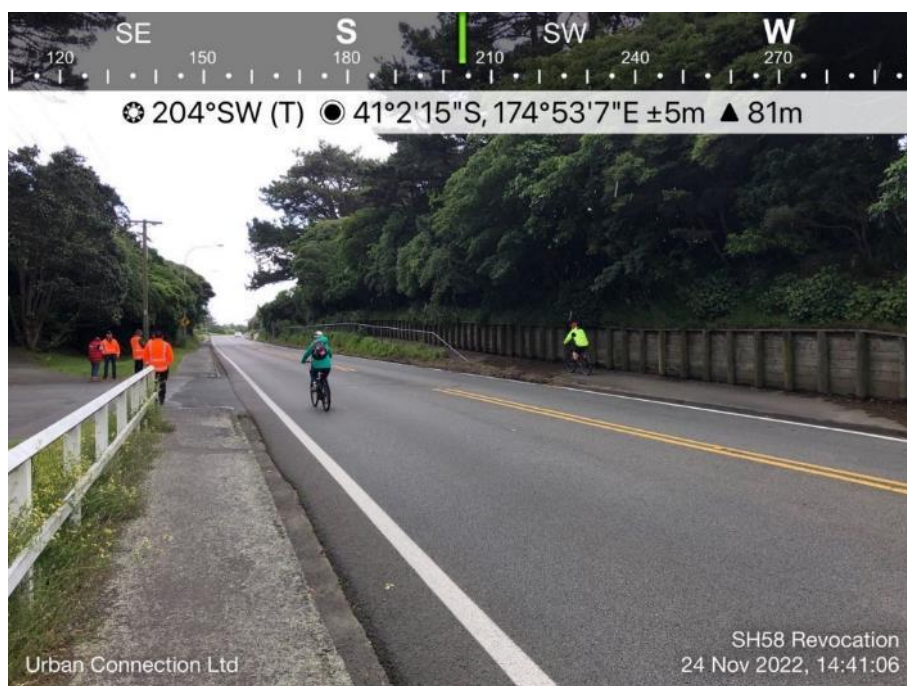
Against vulnerable road users (pedestrians and cyclists)
Probability	Likely	Narrow paths, overgrown vegetation, no treatment on side roads, poor wayfinding signage, poor intervisibility
Severity	Fatal	Impact speeds of 40-50 km/h

Figure 5.6-5 – Cyclist on the carriageway

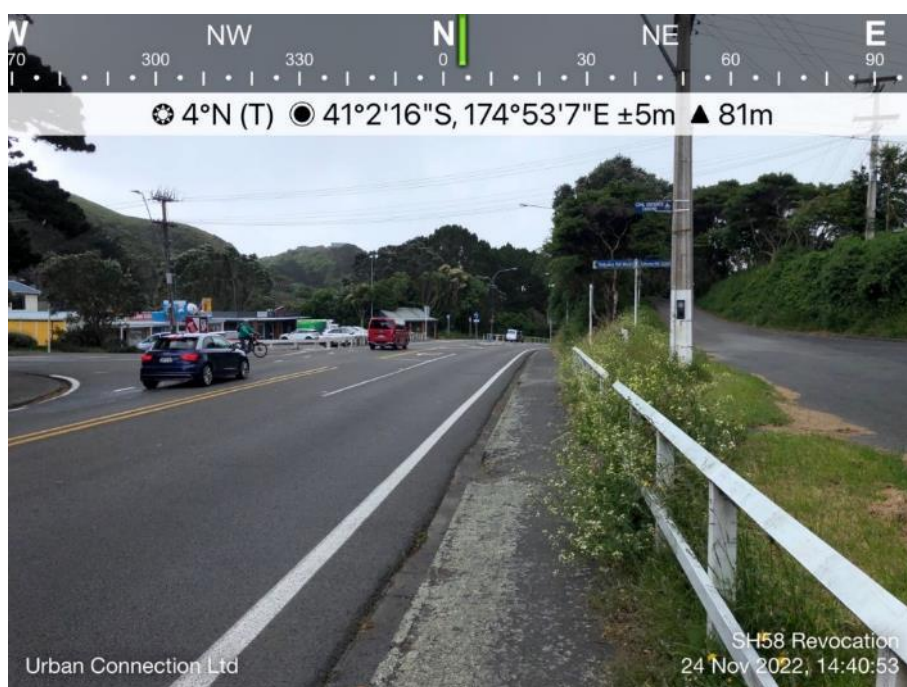
Figure 5.6-6 – Narrow path with overgrown vegetation

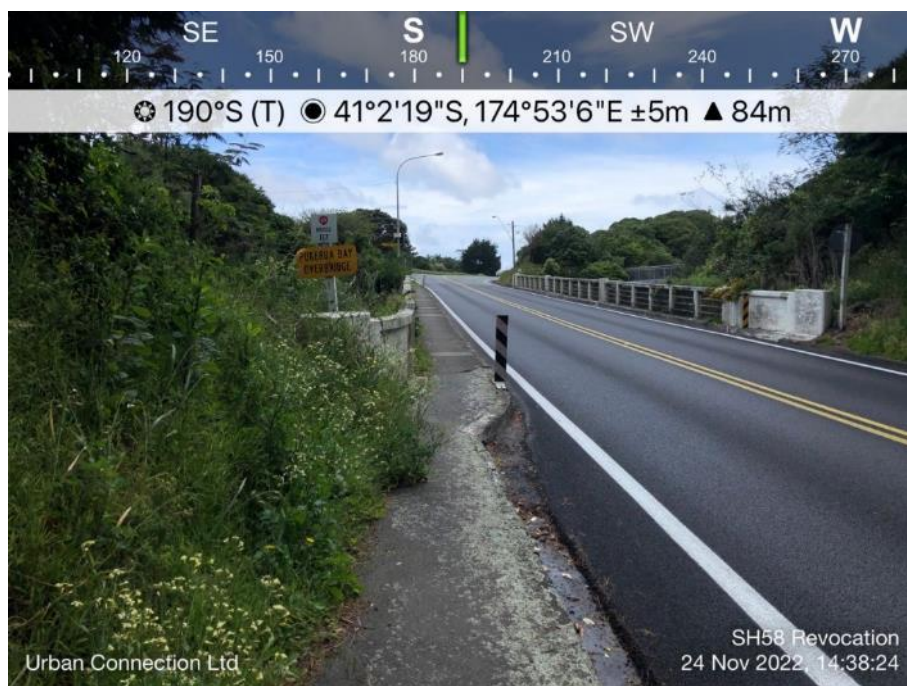
Figure 5.6-7 – Pinch pint at the Pukerua Bay Overbridge

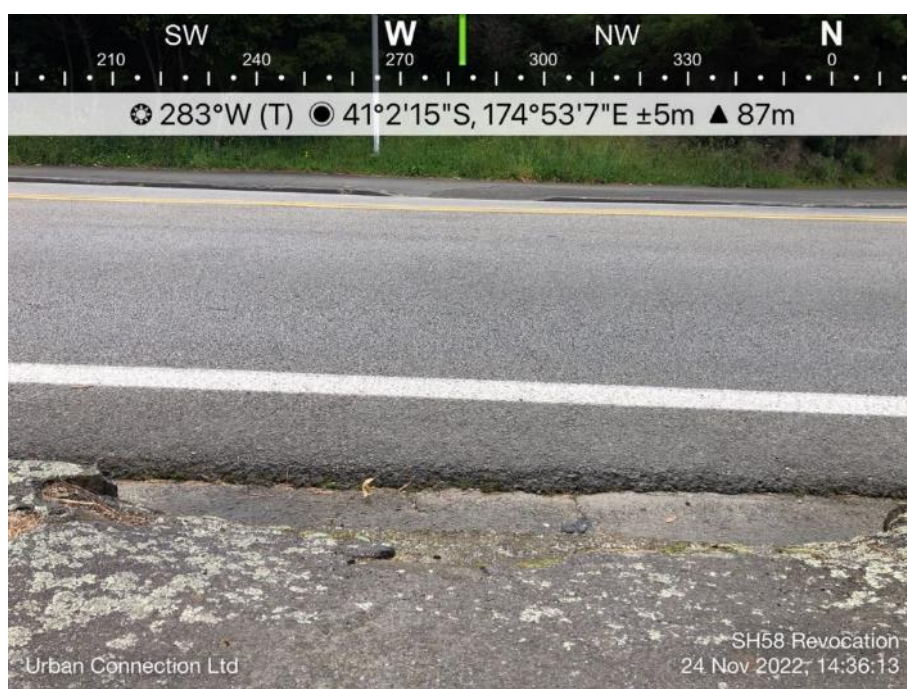
Figure 5.6-8 – Successive resurfacing

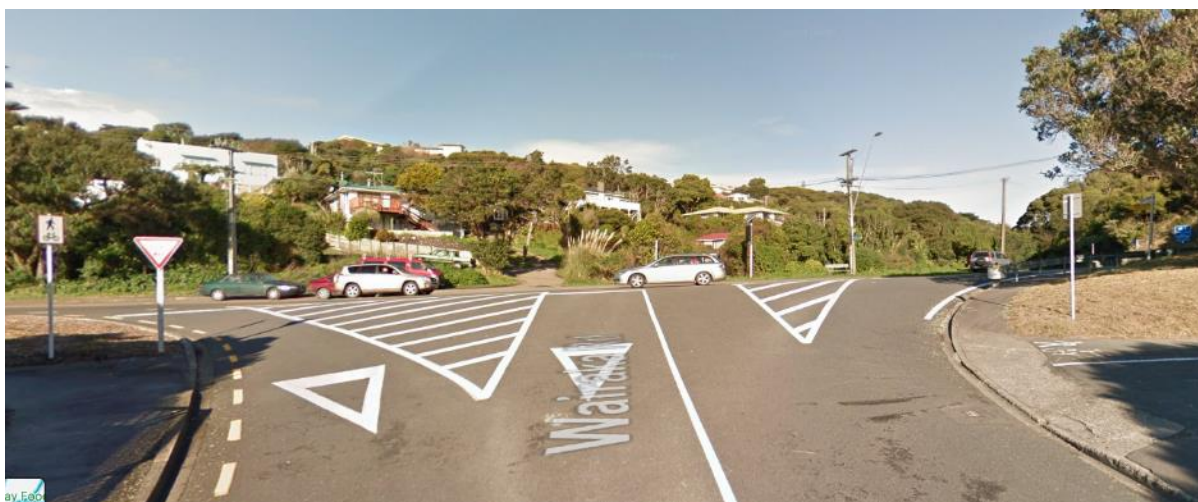
Figure 5.6-9 – Treatment and visibility at the Waikara Road intersection

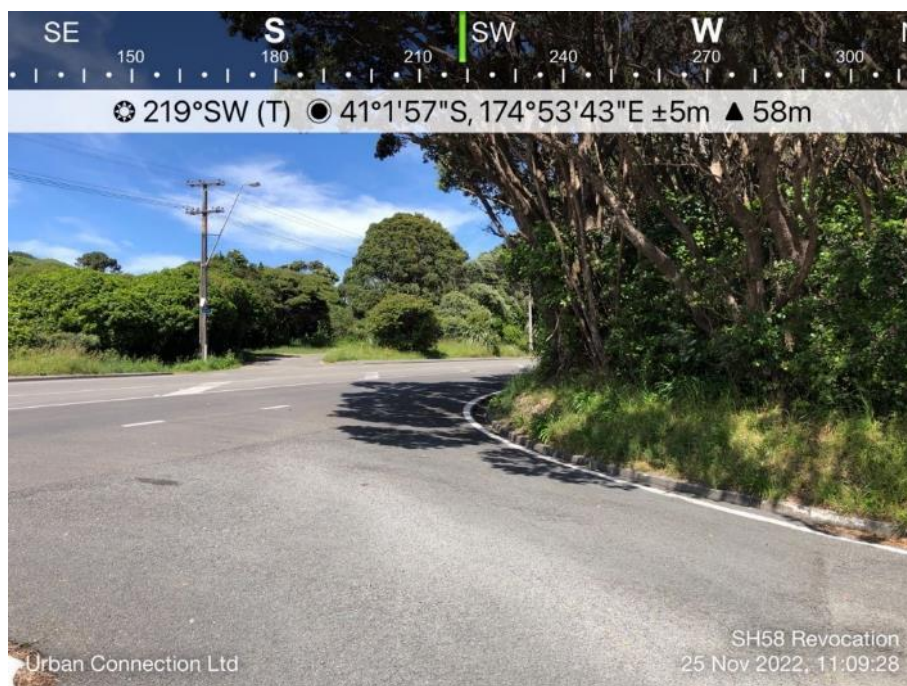
Side-impact at high impact angles
Probability	Very Unlikely	Motorists are expected to approach at low speeds and give way to traffic on SH59
Severity	Serious	Impact speeds of 50 km/h

Figure 5.6-10 – Visibility from Pa Road

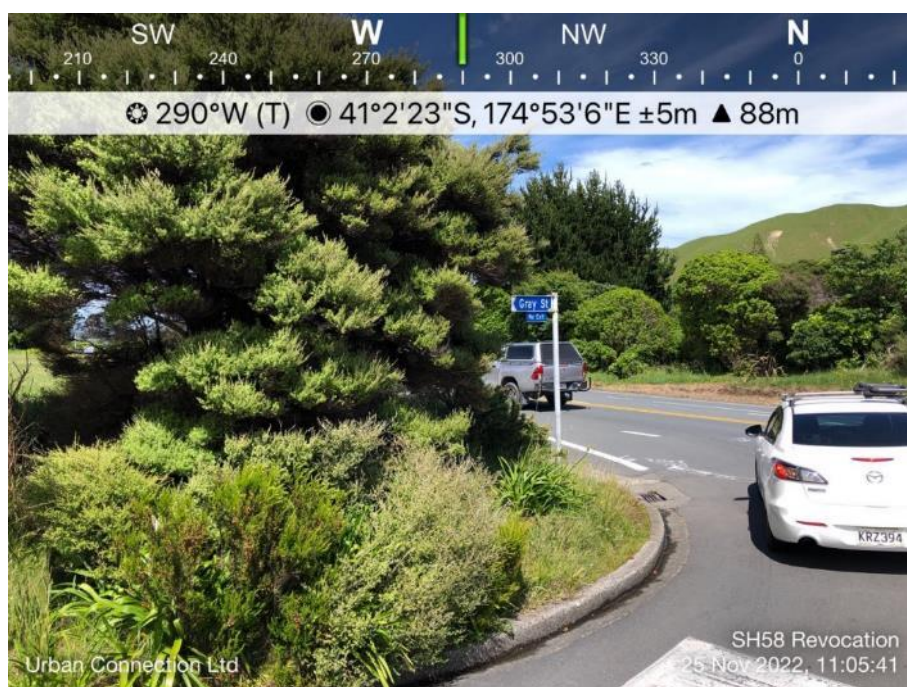
Figure 5.6-11 – Visibility from Gray Street

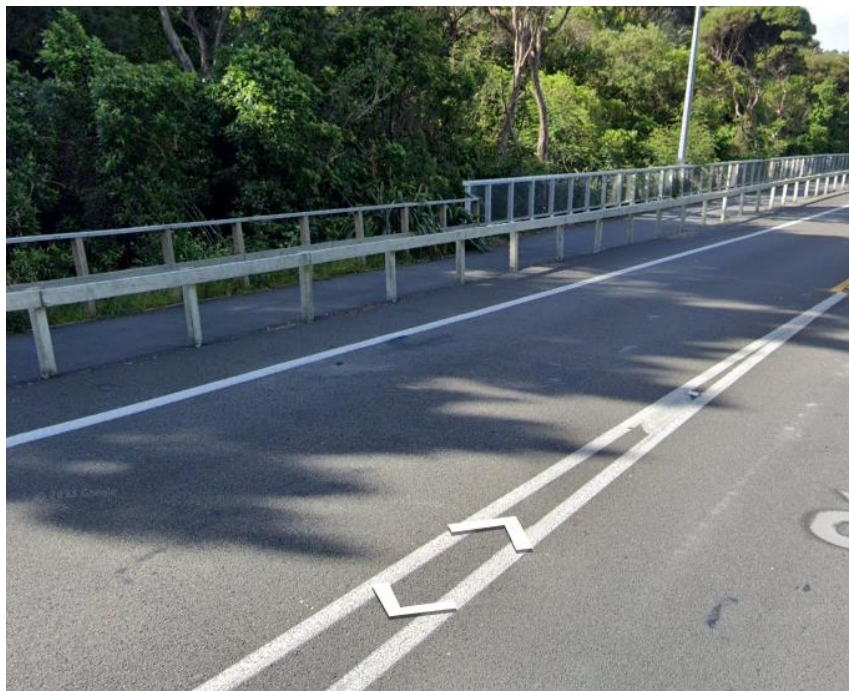
Against non-frangible objects and/or vulnerable road users
Probability	Likely	Windy horizontal alignment, very narrow sealed shoulders, poor forward visibility
Severity	Serious	Impact speeds of 40 to 50 km/h

Figure 5.6-12 – White wooden sight rails

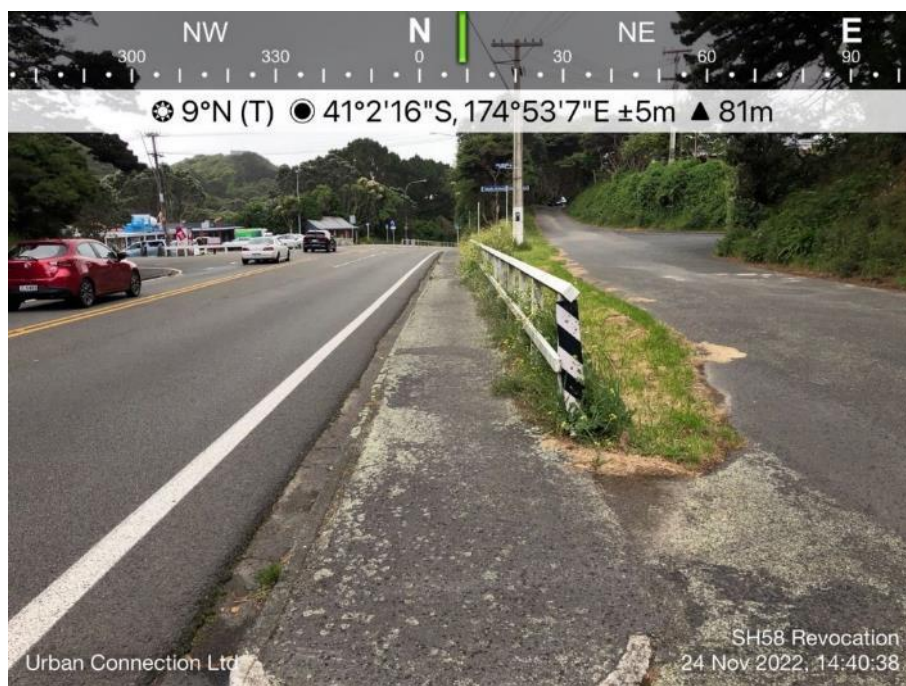
Figure 5.6-13 – White steel rails

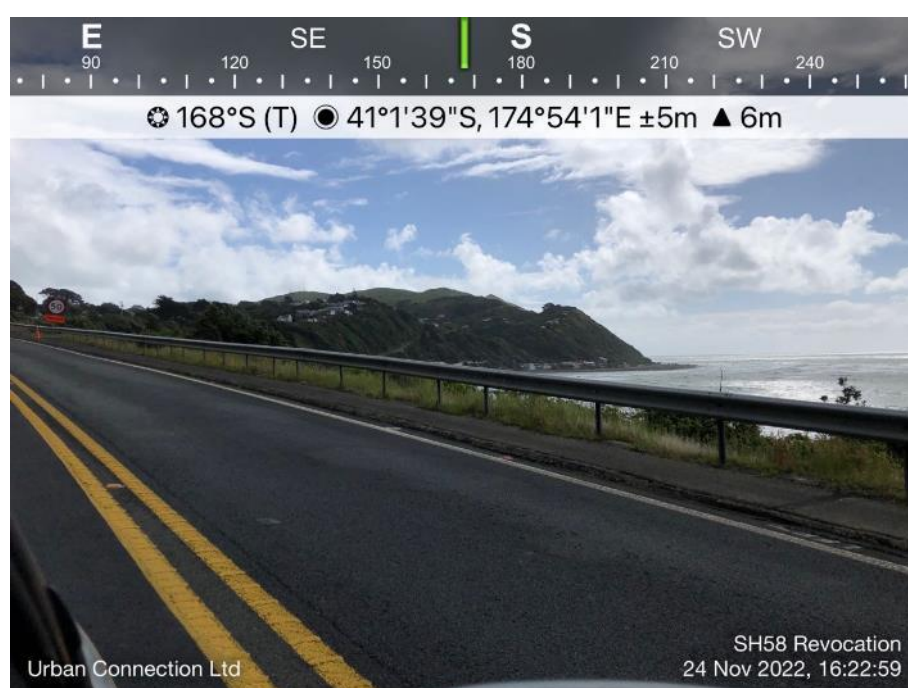
Against vulnerable road users (pedestrians and cyclists)
Probability	Likely	Narrow paths, narrow sealed shoulders, no protection between road and shared path, windy alignment, low height difference between road and shared path
Severity	Fatal	Impact speeds of 70-80 km/h

Figure 5.7-1 – Narrow shared path

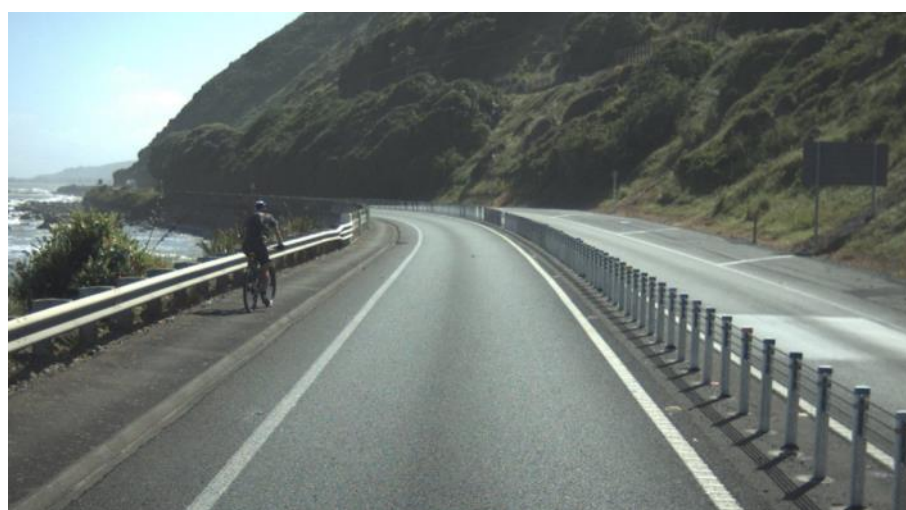
Figure 5.7-2 – Typical configuration and cyclist on the shared path

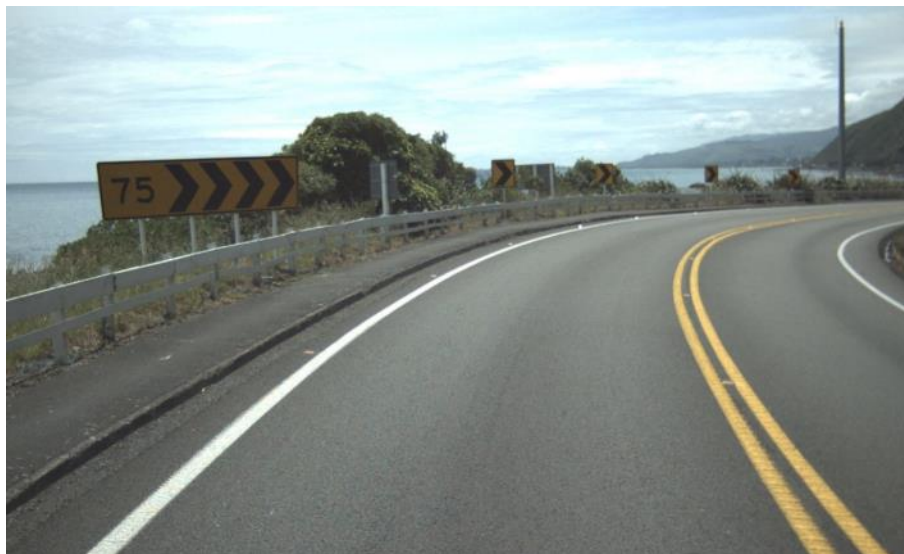
Against unprotected drop-off
Probability	Likely	Windy horizontal alignment, narrow sealed shoulders, poor forward visibility
Severity	Fatal	Impact speeds of 70 to 80 km/h

Figure 5.7-3 – Unprotected drop-off and white wooden sight rails

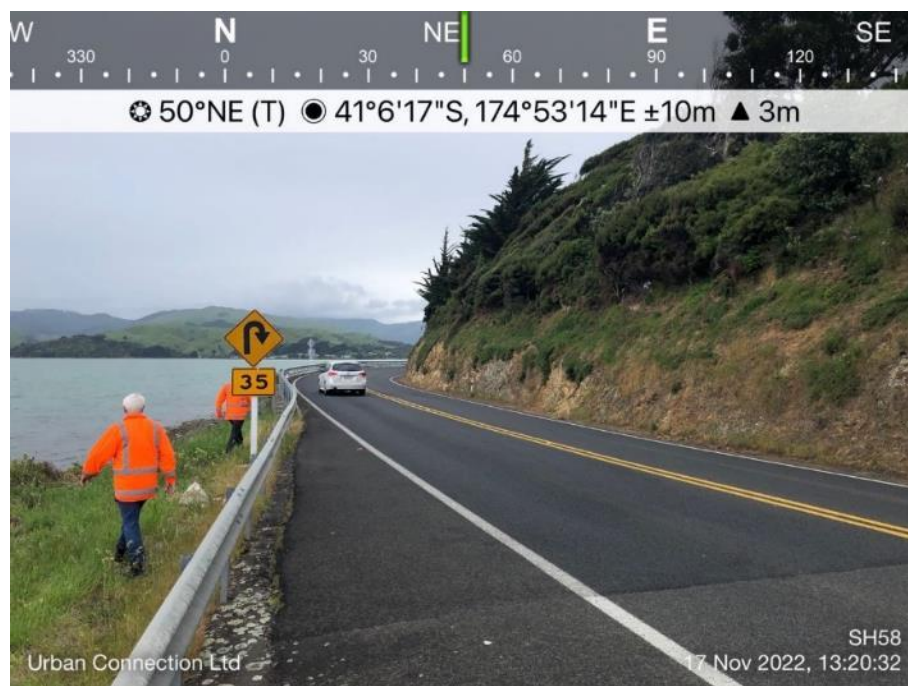
Loss of control/run-off-road into the water
Probability	Likely	Poor delineation combined with windy horizontal alignment, very narrow sealed shoulders, poor forward visibility
Severity	Fatal	Drop-off into the water

Figure 5.8-1 – Curve missing chevron board and indicators
