SH58 & SH59 Porirua Region

Existing Road - Safe System Audit Report

Prepared for Waka Kotahi

REVISION 1 - MARCH 2023

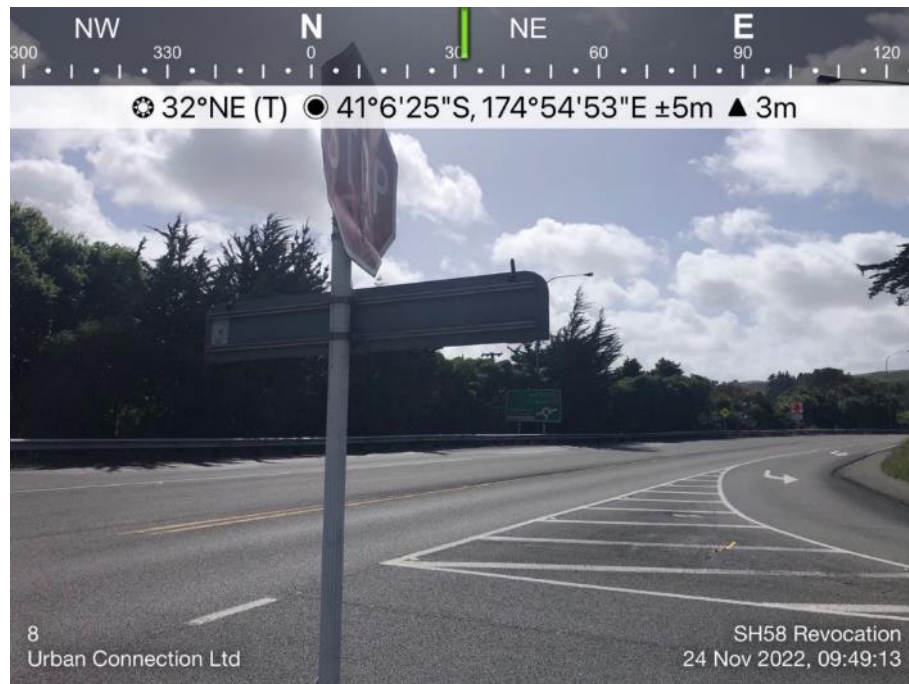
Side-impact at high impact angles
Probability	Likely	Substandard visibility adversely affects decision-making
Severity	Serious	Impact speeds ≥ 50 km/h

Figure 5.8-2 – Visibility and left-turn slip lane at the Joseph Banks Drive intersection

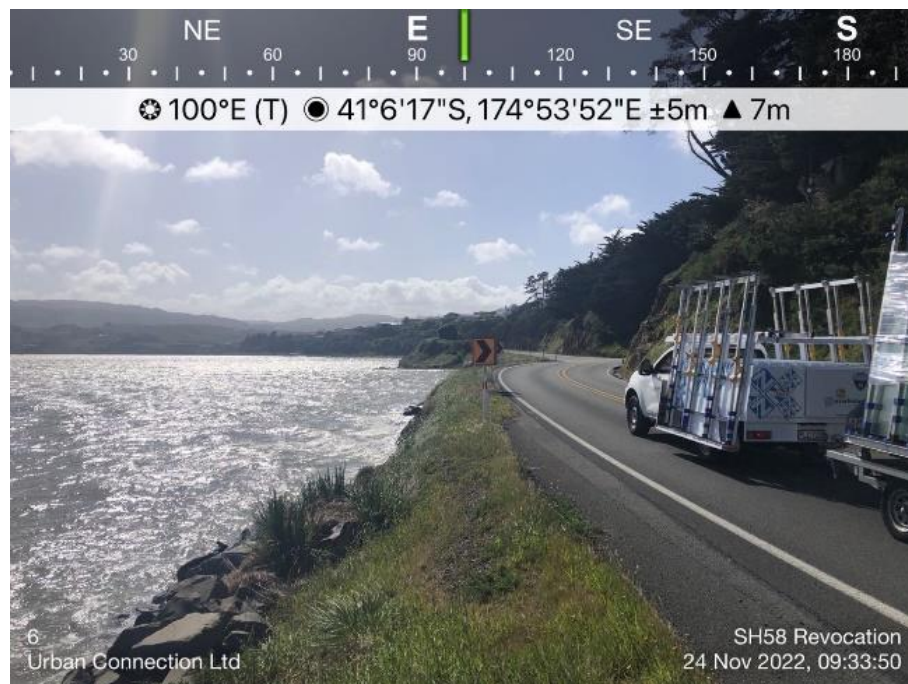
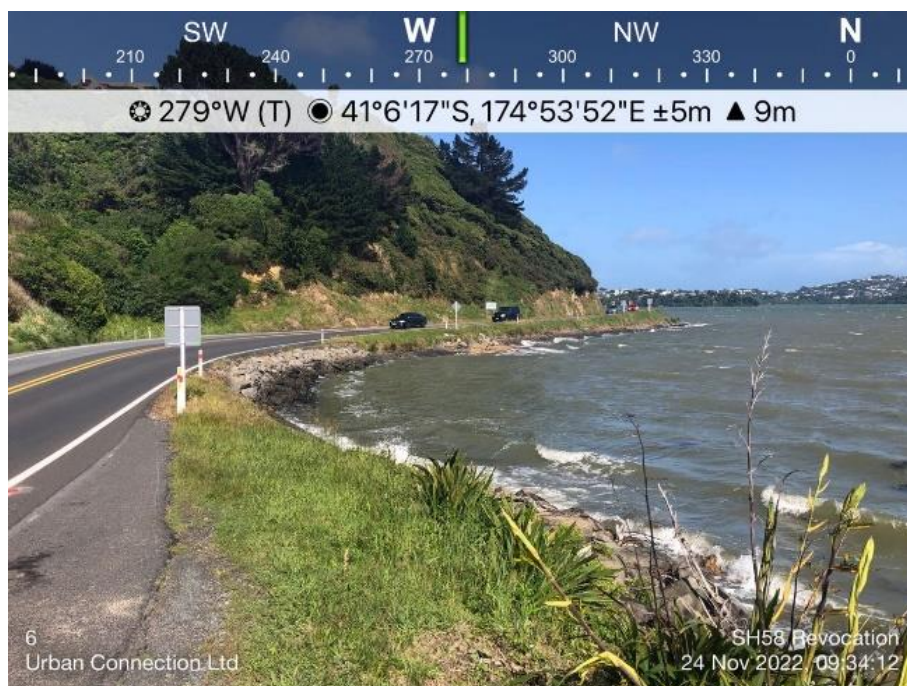
Loss of control/run-off-road into the water
Probability	Likely	Unprotected drop-off combined with out-of-context posted speed, poor delineation, windy horizontal alignment, very narrow sealed shoulders, poor forward visibility
Severity	Fatal	Drop-off into the water

Figure 5.8-3 – Unprotected drop-off into the water hazard

Figure 5.8-4 – Unprotected drop-off into the water hazard

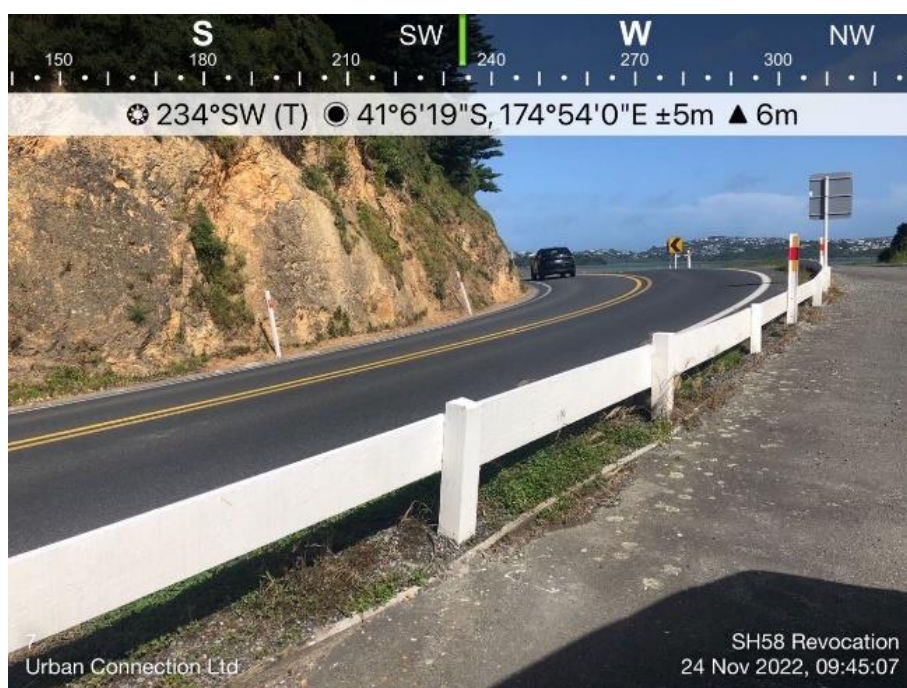
Figure 5.8-5 – Existing white wooden sight rail

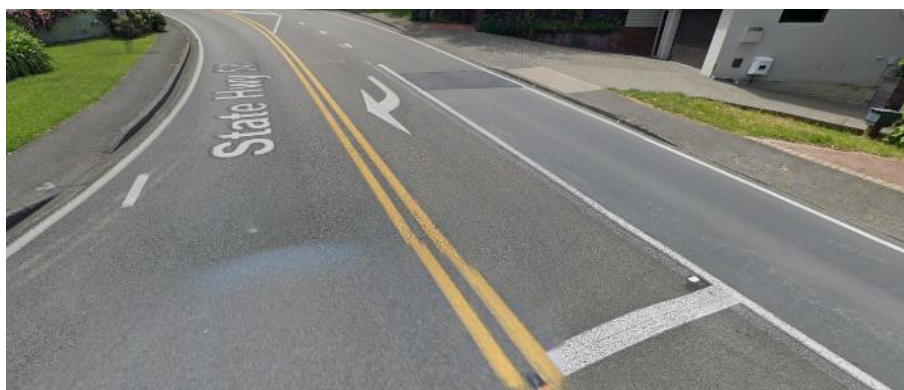
Against vulnerable road users (pedestrians)
Probability	Likely	Lack of crossing opportunities, poor intervisibility due to windy alignment, no TGSIs and poor kerb crossings
Severity	Fatal	Impact speeds of 40-50 km/h

Figure 5.9-1 – Disconnected kerb crossing

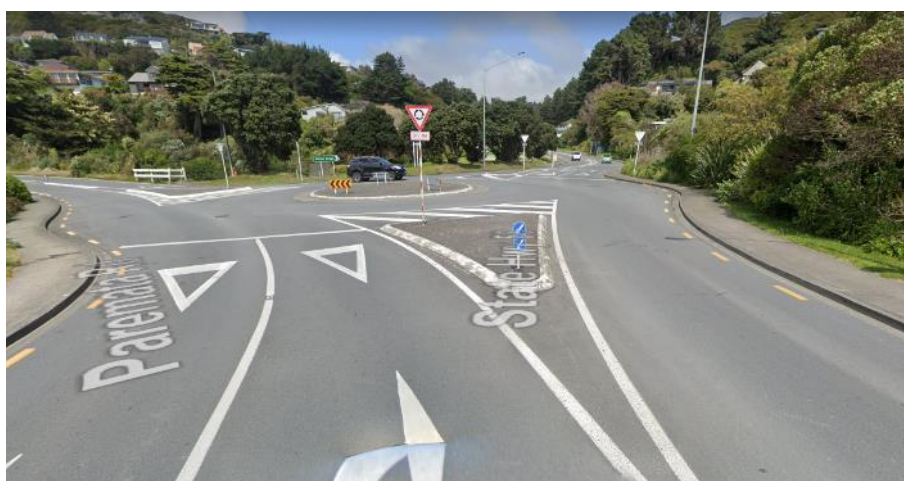
Figure 5.9-2 – No pedestrian crossing treatment at Postgate Drive roundabout

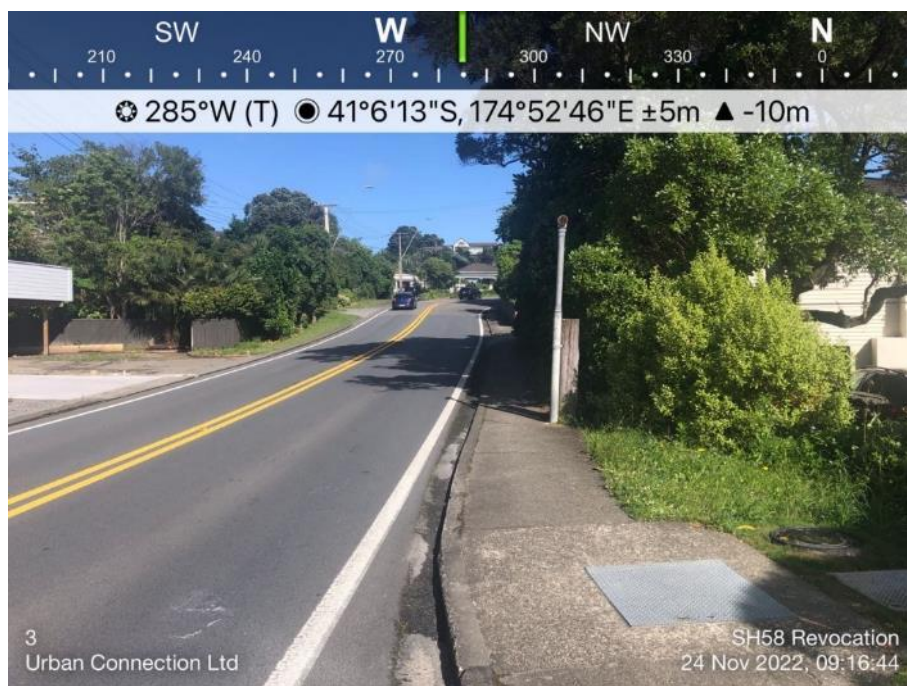
Against vulnerable road users (pedestrians and cyclists)
Probability	Likely	Narrow paths, overgrown vegetation, no treatment on side roads, poor intervisibility and connectivity
Severity	Fatal	Impact speeds of 40-50 km/h

Figure 5.9-3 – Narrow path and overhung vegetation

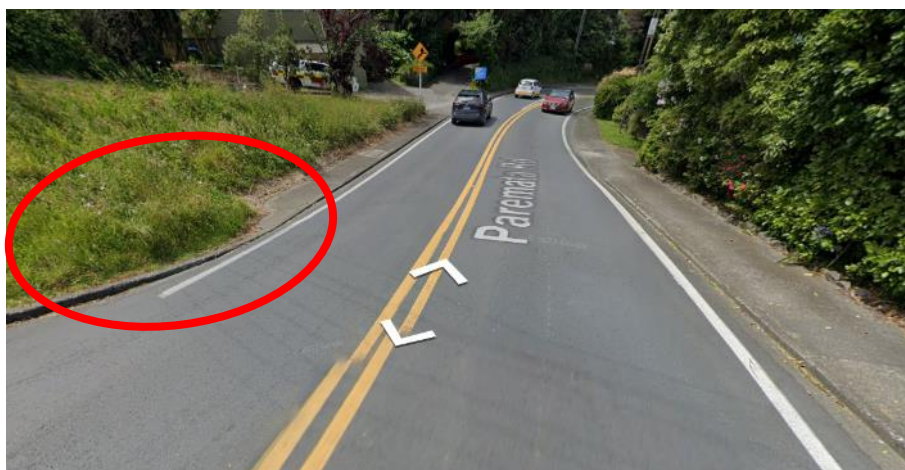
Figure 5.9-4 – Connectivity issues with no crossing opportunity

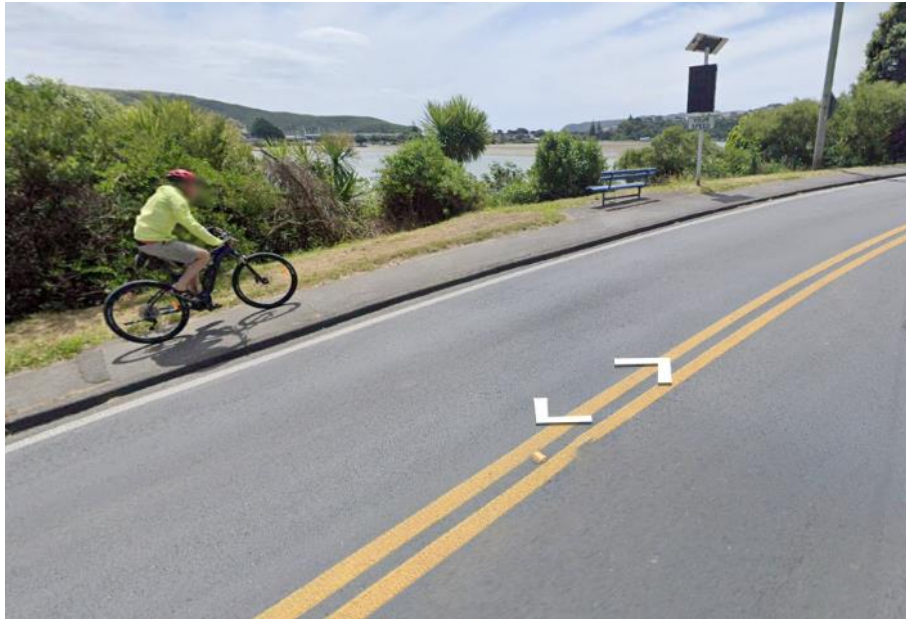
Figure 5.9-5 – Cyclist riding on the footpath

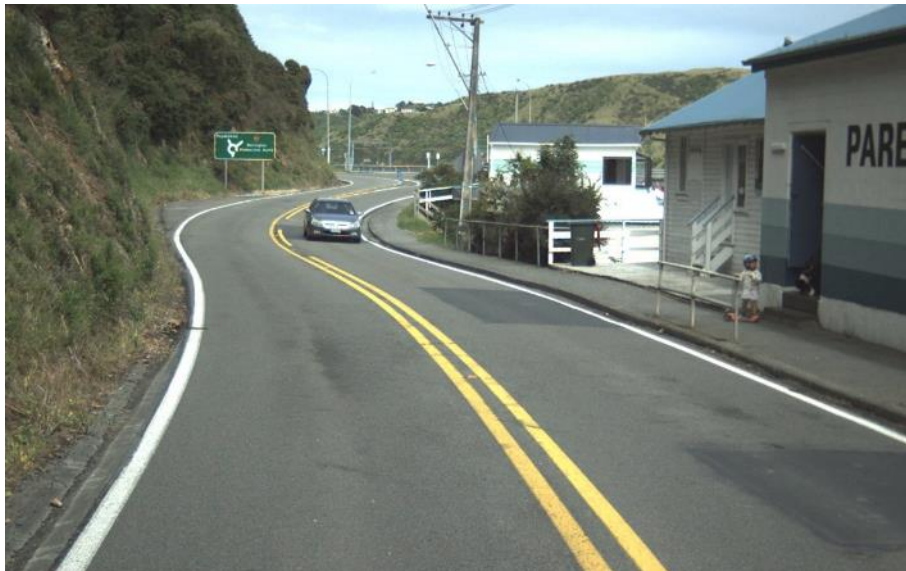
Figure 5.9-6 – Typical configuration and child with a scooter

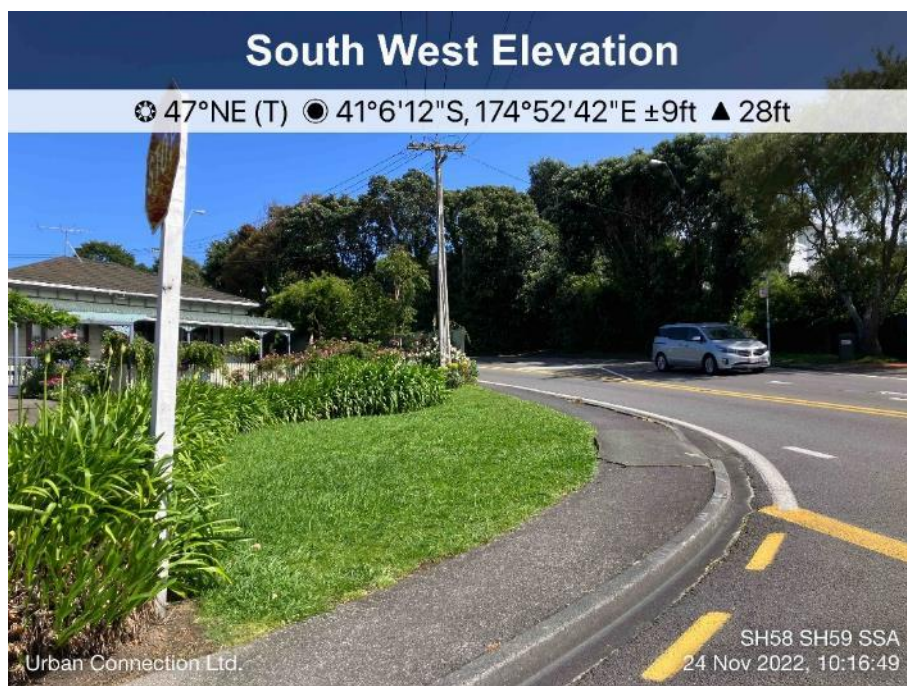
Side-impact at high impact angles
Probability	Likely	Substandard visibility adversely affecting decision-making
Severity	Minor	Impact speeds < 50 km/h

Figure 5.9-7 – Visibility at the Oak Avenue intersection

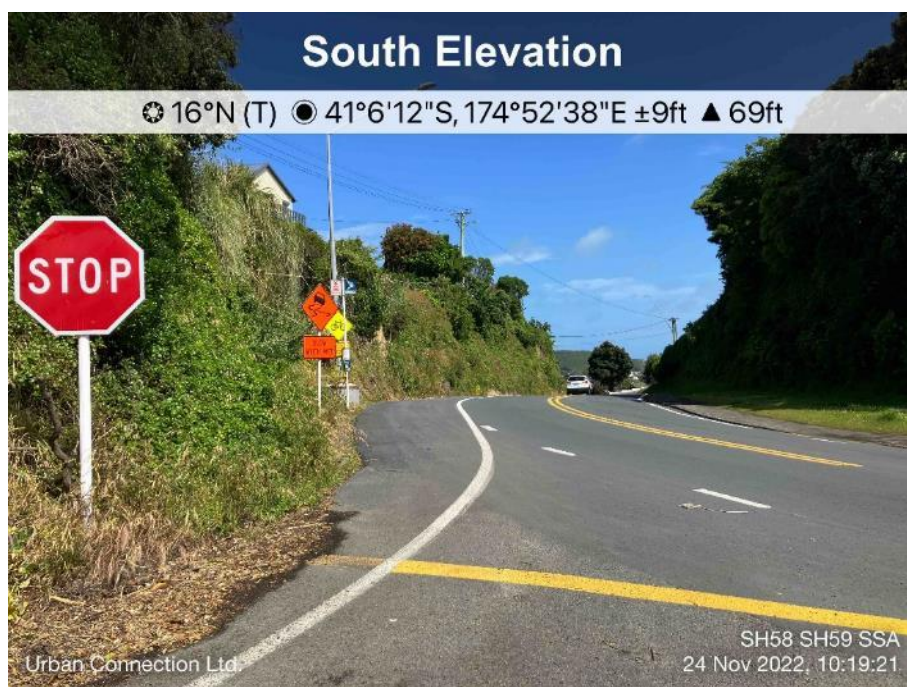
Figure 5.9-8 – Visibility at the Seaview Road intersection

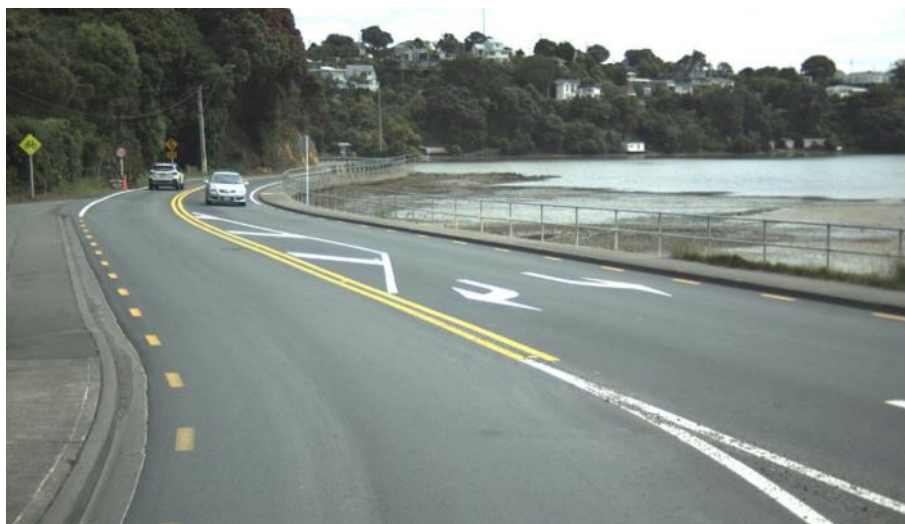
Loss of control/run-off-road into the water
Probability	Likely	Unprotected hazards combined with windy horizontal alignment, very narrow sealed shoulders and poor forward visibility
Severity	Fatal	Drop-off into the water

Figure 5.9-9 – Unprotected drop-off into the water hazard

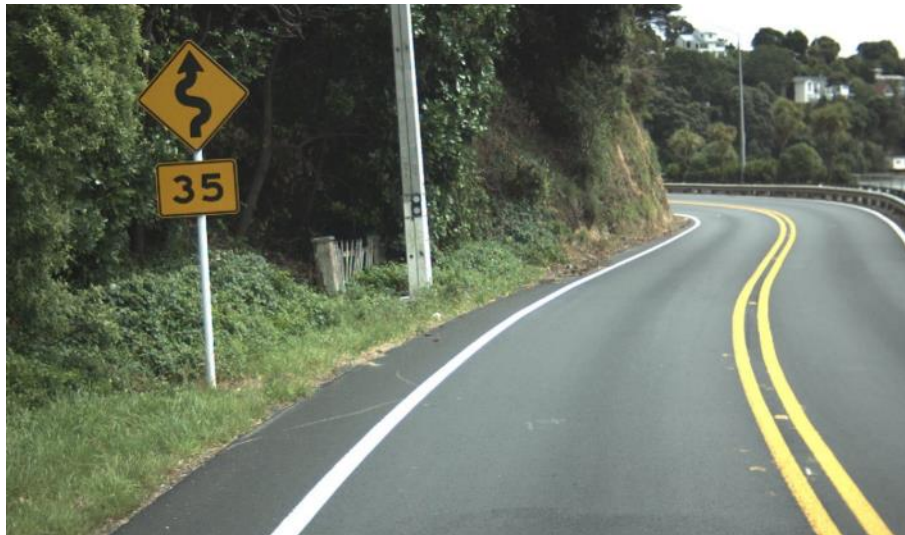
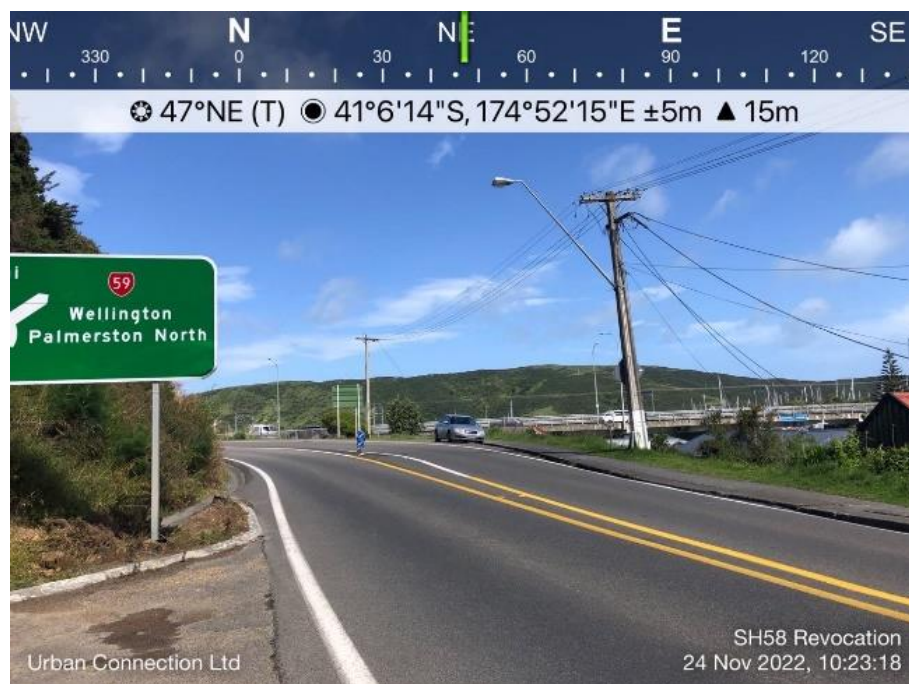
Figure 5.9-10 – Unprotected power pole

Figure 5.9-11 – Unprotected power pole

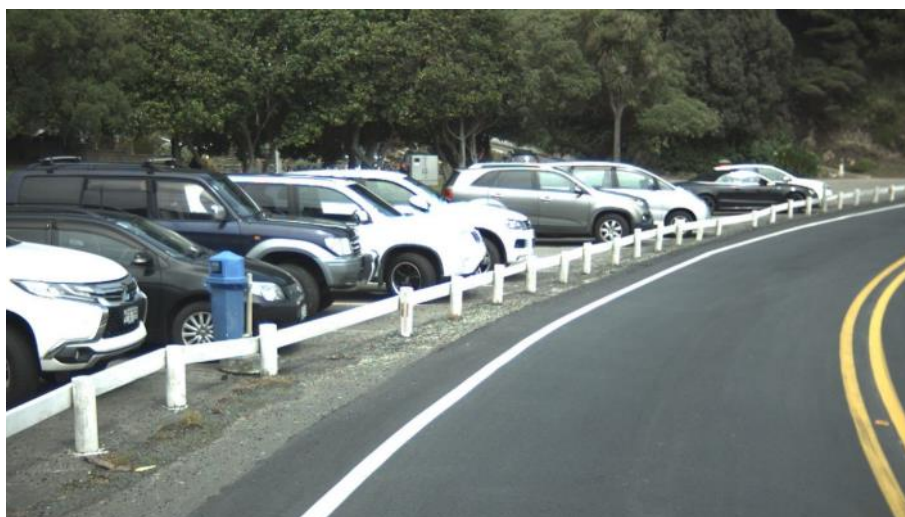
Figure 5.9-12 – Existing white wooden sight rail
