SH58 & SH59 Porirua Region

Existing Road - Safe System Audit Report

Prepared for Waka Kotahi

REVISION 1 - MARCH 2023

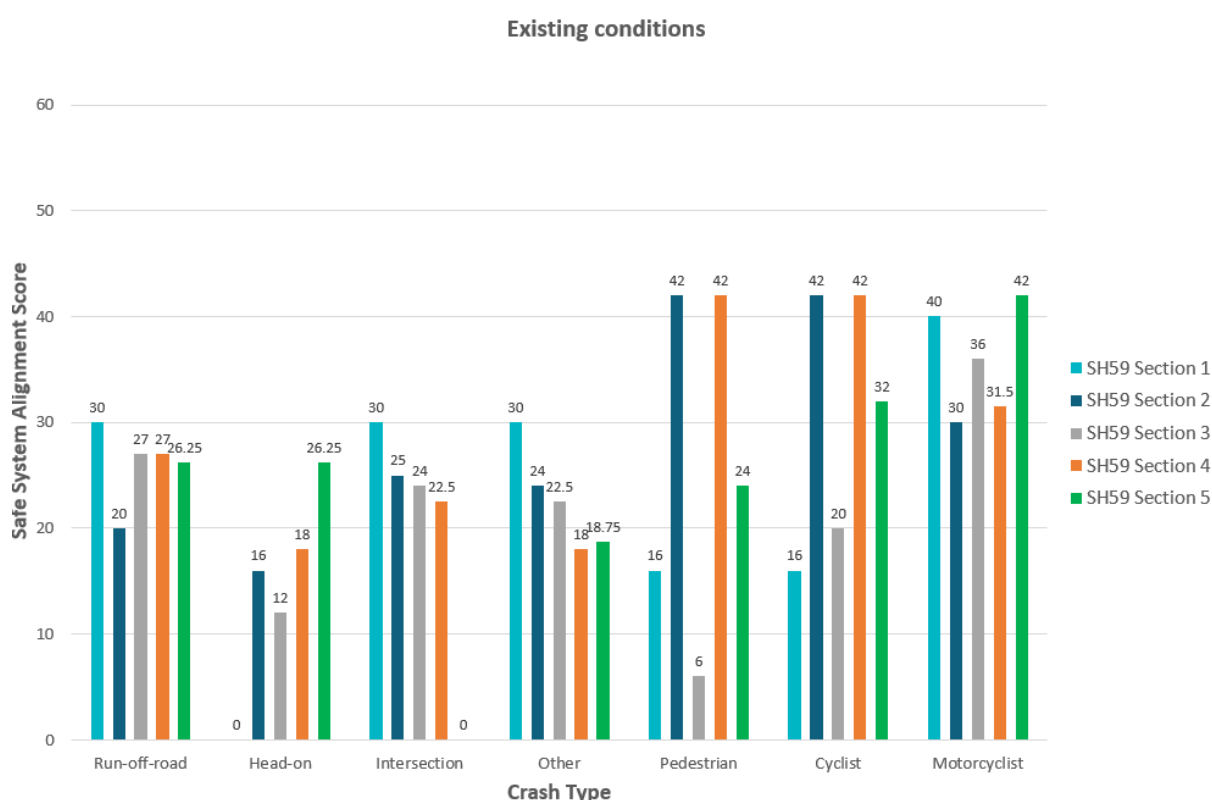
Figure 4.1-1 - Safe System Assessment Score Summary – SH59 – Sections 1 to 5

The assessment shows that the worst alignment with Safe System principles is given on crash types involving vulnerable road users (pedestrians, cyclists and motorcyclists). This is predominantly driven by a high exposure, especially through Mana Esplanade and Pukerua Bay, and a high likelihood due to the poor walking and cycling facilities available. Conflict impact speeds are also expected to exceed the biomechanical tolerances for vulnerable road users (20 to 30 km/h), suggesting that, potentially, serious or fatal injuries could result in the event of conflicts involving these users.

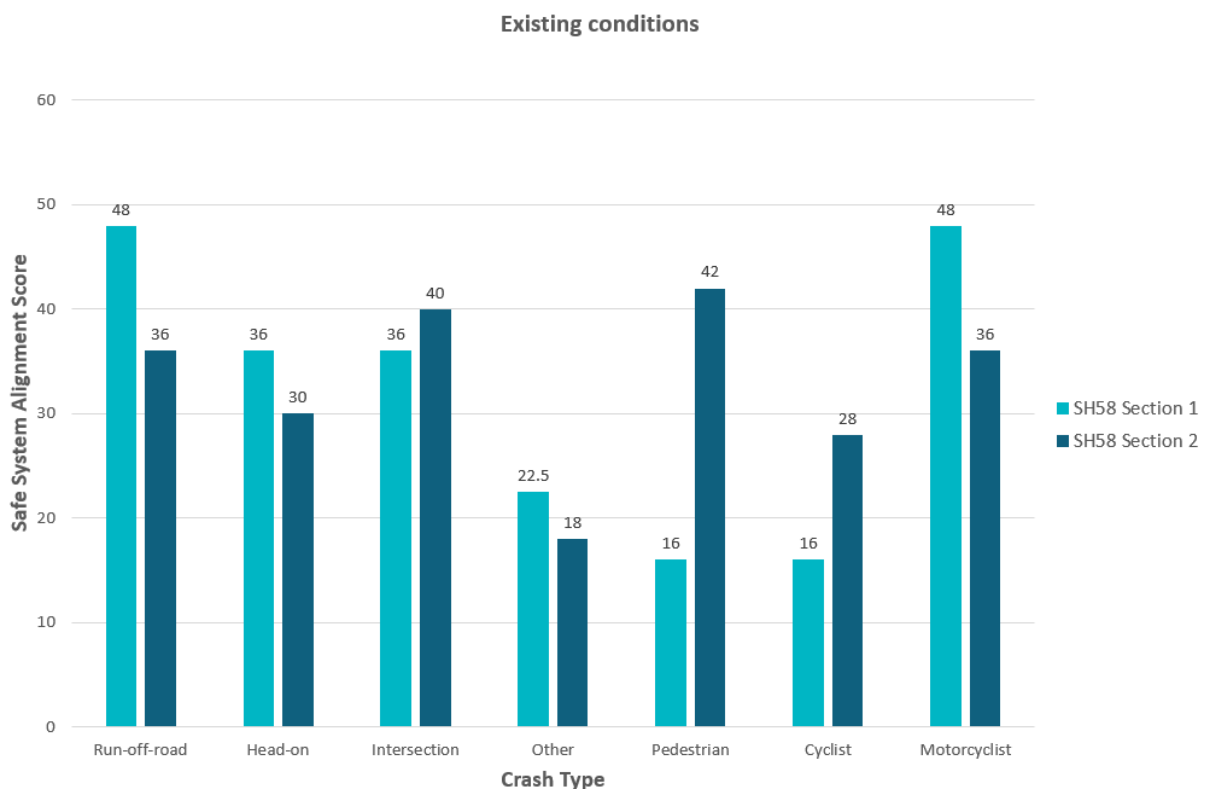
Figure 4.1-2 - Safe System Assessment Score Summary – SH58 – Sections 1 and 2

The worst alignment with Safe System principles is related to run-off-road crash types, including those involving motorcyclists, especially in the coastal section of SH58 (Section 1). This is mainly related to the windy/tortuous horizontal alignment combined with unprotected drop-offs into the water. The road cross-section has minimal-width sealed shoulders with poor delineation and the relatively high posted speed limit also adversely contributes to run-off-road crashes.

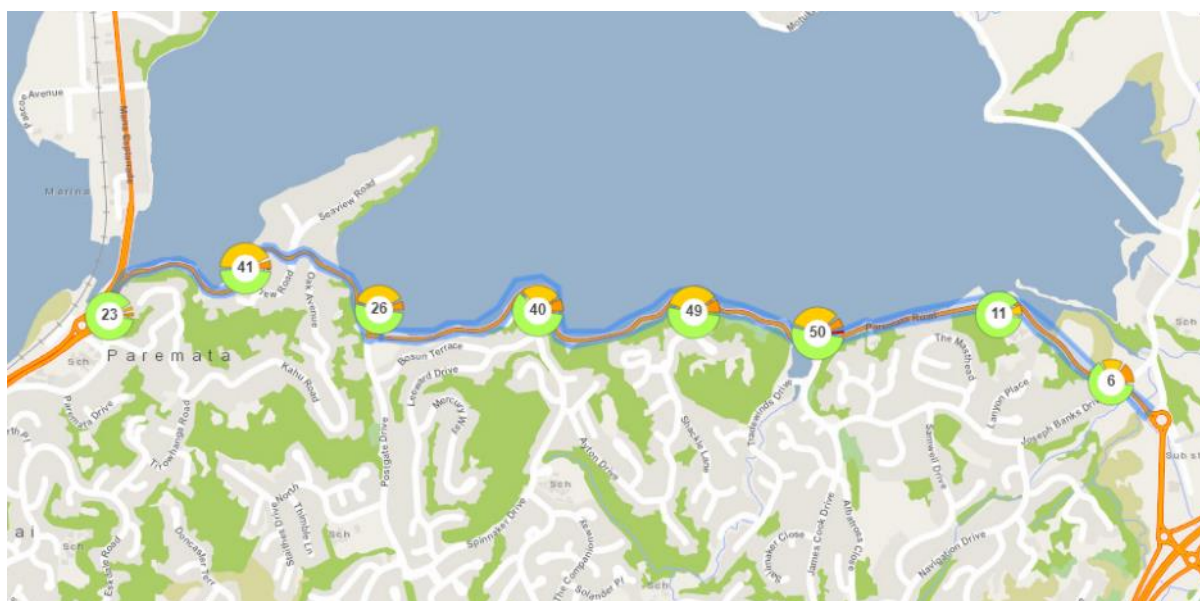
Figure 5.1-2 – Crash Locations – SH58

Indeed, the crash records, as shown in Figure 5.1-2, indicate a high number of fatal and serious crashes in this section. With reduced traffic volumes since the Transmission Gully, the crash frequency is likely to reduce. However, the high-risk crash trends are likely to remain unchanged, given that the infrastructure in place is also unchanged.
